# AKOSOMBO HYDRO-ELECTRIC POWER STATION GENERATOR THRUST BEARING UPGRADE CASE STUDY

**Co-Authored by:** Ken Arthur, Chief Mechanical Engineer of Akosombo Generating Station of the Volta River Authority and Mike Dupuis, Bearing Specialist & President of Hydro Tech Inc.

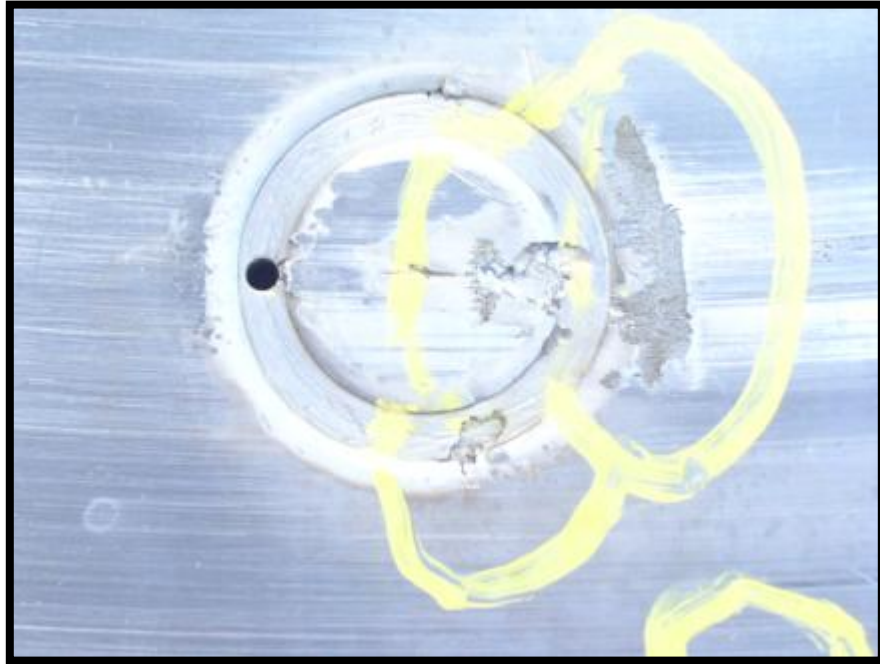
The spring optimization definitely reduced thrust bearing operating temperatures; nonetheless, the emergence of a rather rapidly recurring cavitation damage phenomenon became obvious on the thrust pad surfaces. This pitting effect was normally concentrated within, and around, the High-Pressure Oil Injection (HPOI) groove ring, towards the trailing end.

There are few cases of cavitation on thrust bearing pads. A design flaw must exist to allow cavitation to manifest itself when caused by a sudden pressure drop. In this particular case, the highest measured average bearing pressure is approximately 4.07 Mpa; however, this 4.07 Mpa is an average pressure. There also exist higher and lower pressures on the surface of the bearing. Generally, a higher load area is located in the middle of the bearing pad surface toward the trailing edge, close to where the High-Pressure Oil Lift (HPOL) ports are. The HPOL port is where the most significant pressure drop occurs due to the change in oil film thickness and/or pressure (step in the babbitted surface and gap between the thrust bearing runner plate segments). With the increased thrust, the oil film between the Babbitt thrust bearing pads and thrust bearing runner plate has decreased, while the average pressure has augmented. This increased the pressure drop at the thrust bearing runner plate split, as well as increasing its subsequent effect on the Babbitt due to close proximity, resulting in the thrust bearing pads showing signs of cavitation pitting (Photo 1).

Photo 1  
Old Babbitt Bearing Pads With Cavitation

Superior PTFE bearing pads with higher load capacity were installed to replace the traditional Babbitt bearings, which could not adequately match the increased thrust load of the new turbine runners. The new PTFE thrust pads for Akosombo feature compound tapers at the leading edge to facilitate oil flow and wedge formation, as well as pad eccentricity to permit higher specific load capacity. Using the PTFE bearing pads also allowed elimination of the HPOL system removing another potential source for cavitation.

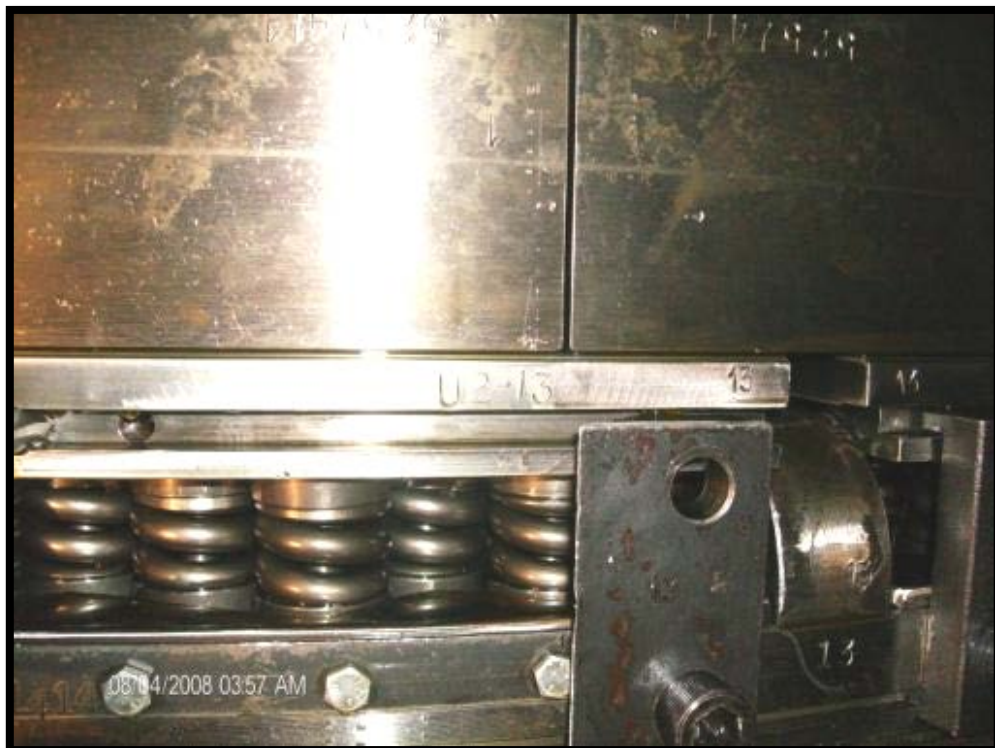
Photo 2  
Old Runner Plate With Gap Between Segments

These problems were fundamentally attributed to the increased hydraulic thrust load of the new replacement turbine runner; however the original bearing was already susceptible to cavitation due to gaps in the runner plate quadrants. Prior to the turbine upgrade, there was at least one incident where cavitation was discovered on a bearing pad. At the time of discovery, the cavitation was considered to be porosity in the Babbitt. No further investigation was conducted at this time due to the area being small (approximately .75 inches in diameter).

The solution provided by Hydro Tech Inc to address gaps at the splits of the existing rotating rings was a modified design of highly-toleranced segmented rotating rings, which are keyed and bolted together to ensure zero gaps at the splits. This new design would eliminate sudden pressure fluctuations caused by the splits. This type of joining was achieved during installation. The splits were lapped (stoned) to completely eliminate any sharp ends, eventually forming a one-piece thrust bearing rotating ring which was bolted to the thrust block.

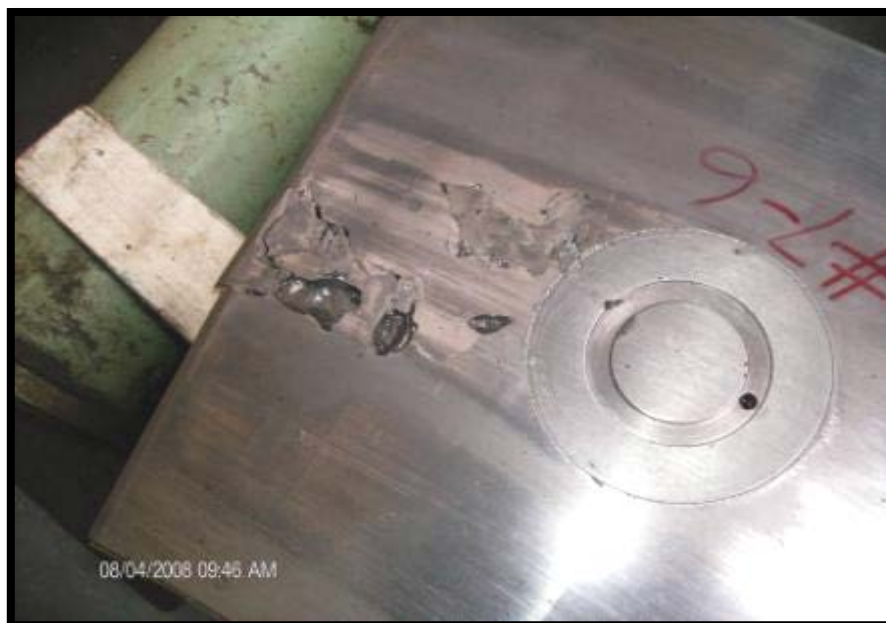
There was also evidence of fatigue failure of the Babbitt surfaces, likely due to thermal

effects, a condition known as “thermal ratcheting”. Thermal ratchet is caused by temperature changes on the bearing surface causing the Babbitt bearing pad to act as a bi-metal strip slightly bending the bearing pad causing a crowning. This is caused by the Babbitt expanding and contracting at a different coefficient of expansion to steel, and the surface of the bearing pad being hotter than the steel backing plate to which the Babbitt is bonded (the thicker the Babbitt, the stronger the thermal ratcheting effect that occurs) (Photo 3).

Photo 3  
Cracked Babbitt

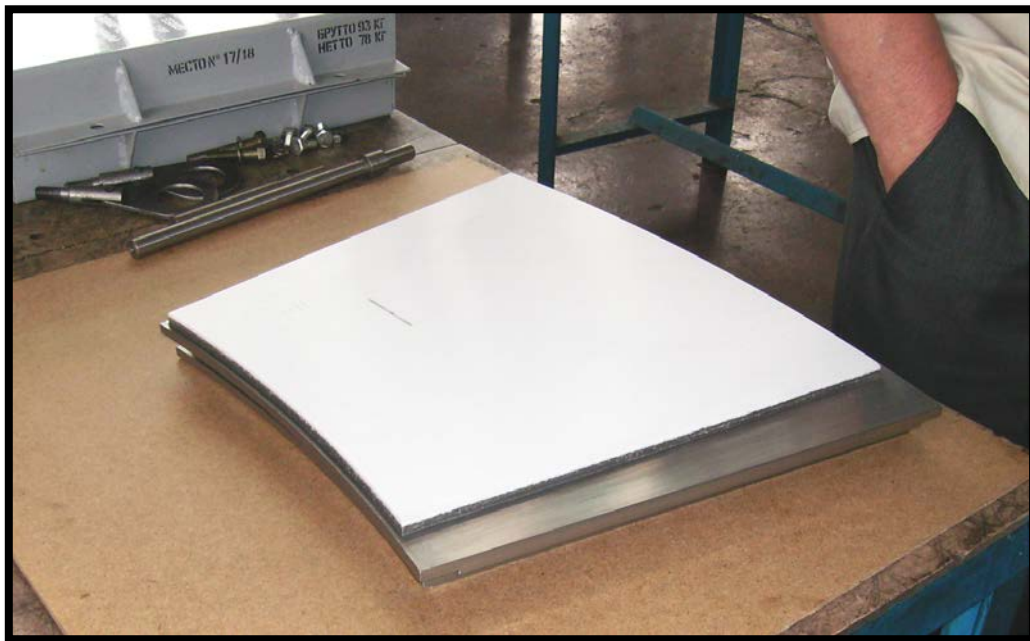
Photo 4  
New PTFE Bearing Pads

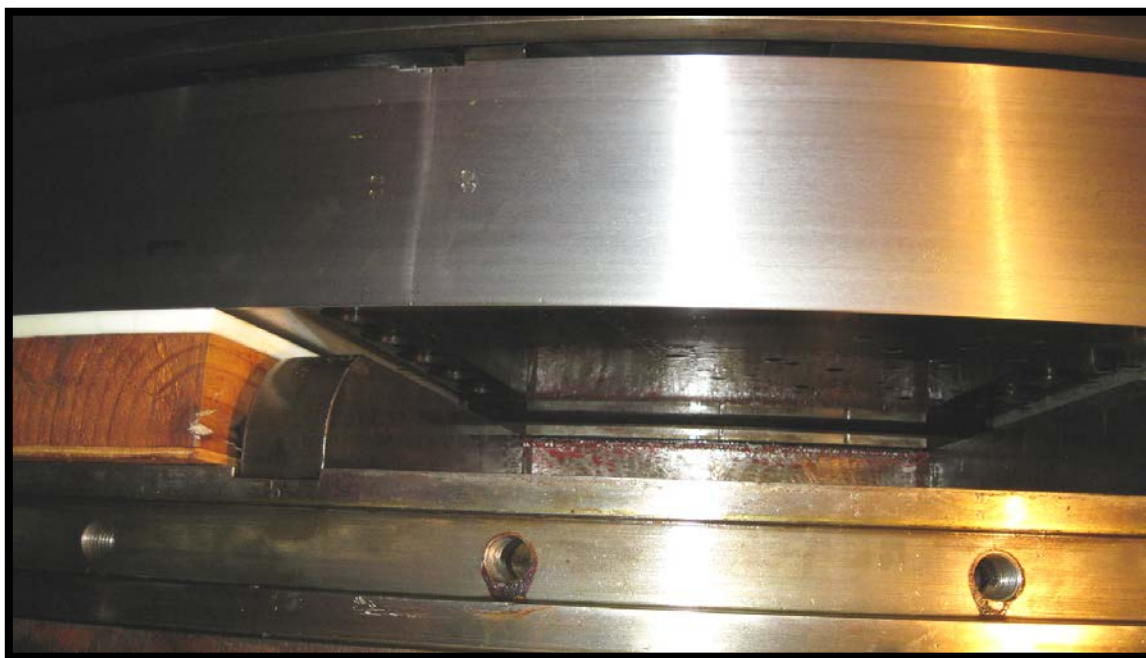
Photo 5  
New Runner Plate Tightly Bolted Together

The new thrust bearing runner plate acts as a solid one-piece ring providing constant pressure on the bearing pads over its entire surface. The bearing pad no longer

experiences pressure fluctuations from the four quadrant slits that originally relieved pressure from maximum PSI to 0 four times per revolution.
