Site Unit #1

PTFE Thrust Bearing Inspection

after 15 years of service

Heavily Loaded PTFE Thrust Bearing Shows Little Wear After 15 Years

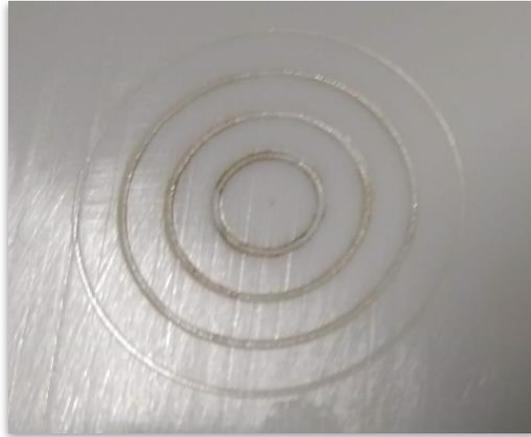
In this particular thrust bearing, there are two rows of pads: sixteen on the outer diameter and eight on the inner diameter. Four of the outer bearing pads and two of the inner bearing pads are machined with two indicators each: one near the outer diameter and one near the inner diameter, both towards the trailing edge of the pads. The indicators consist of four concentric circular grooves, with depths starting at 0.05 mm [0.002"] on the outside and incrementing in 0.05 mm [0.002"] steps to 0.20 mm [0.008"] for the innermost groove. Once the 0.20 mm groove can no longer be observed, the pads must be replaced or resurfaced to restore their leading and trailing edges.

Typical Wear indicators on PTFE thrust bearing pads

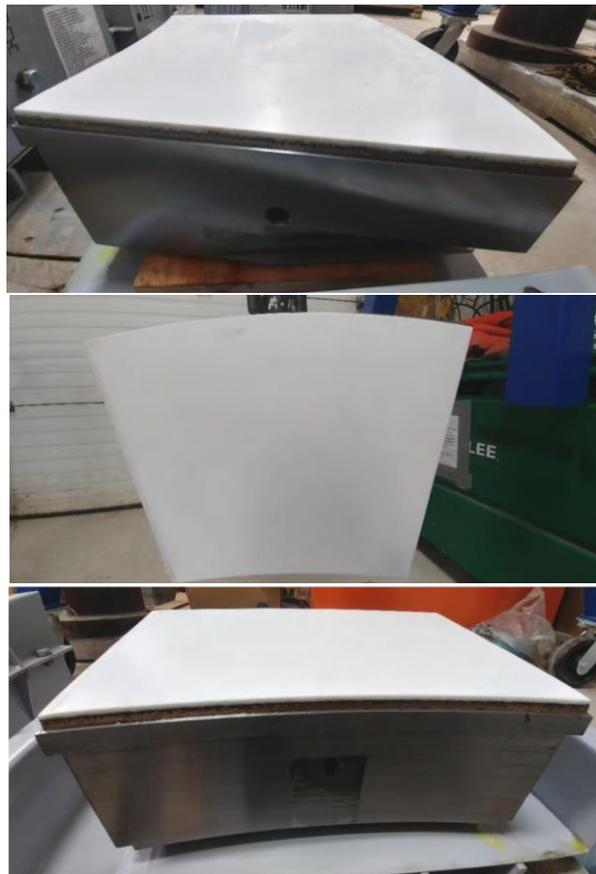
- Measurements indicated that the current wear was 0.035 mm [0.0015"] after 15 years of service. At this wear rate, the bearing pads had approximately 70 years of service life remaining before replacement / resurfacing would be required.
- Dimensional inspections indicated that the pad parallelism and overall thicknesses were still within the original manufacturing specification.
- The visual inspections did not reveal any serious defects, such as crack indications on the PTFE surfaces or at the liner-shoe interface. As noted above, heavy grooves were observed on some of the pads, likely caused by contamination of the bearing oil. This localized damage did not affect the condition of the rest of the pad, and no remedial action was required.

As Found Condition of Typical PTFE Pad
