## **KERR GS THRUST BEARING REPLACEMENT**

Gary Peterson, Maintenance Manager, *Energy Keepers Inc.* USA

Mike Dupuis, President, *Hydro Tech Inc.* Canada

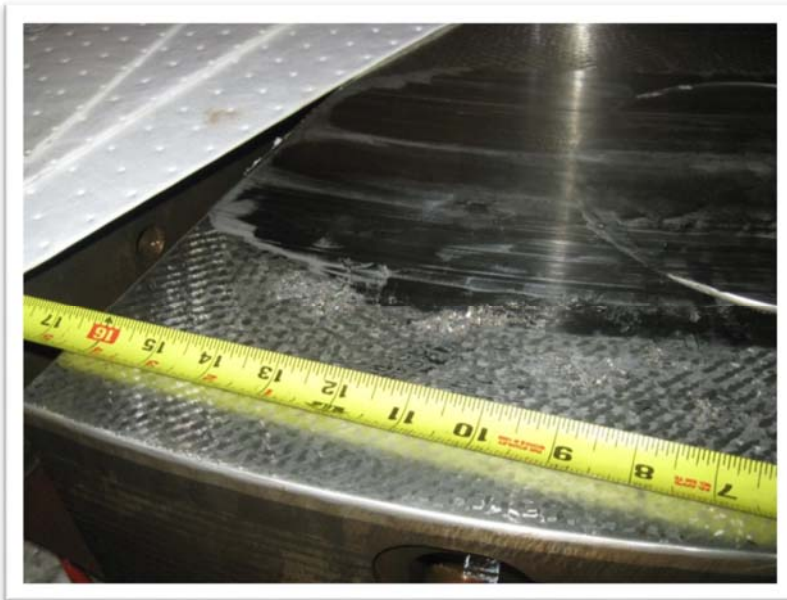
A definitive cause of this thrust bearing failure was a cooling water failure and a contributing factor was that the temperature shutdown was also set too high. The overly elevated setting of the temperature shutdown was implemented due to the elevated operating temperatures normally encountered. This elevated setting did not allow an adequate safety factor to prevent damage to the bearing. However, when the thrust bearing was disassembled, cracking at the outer trailing portion in the Babbitt was also noted on all eight (8) bearing pads. Some of the Babbitt in the cracked Babbitt pieces appeared to be missing. It is possible that some Babbitt had become loose, and that a small fragment of Babbitt had lifted and initiated the bearing wipe.

Inspection of the thrust bearing pads found the cracking and defects to have occurred on each of the eight bearing pads in the same location. Defects were consistent on each pad in appearance, having a size of about 2 inches by 3 inches (Photos 4 & 5). The cracking was also located close to the wiped areas on the thrust pads. It is possible that additional cracking was within the wiped area of the thrust pad, but was now covered with the smeared Babbitt. As noted in the 1977 failed thrust bearing report, the cracking was again located towards the trailing edge on the outer diameter of the thrust bearing pad.

Photo 5: Wiped thrust bearing

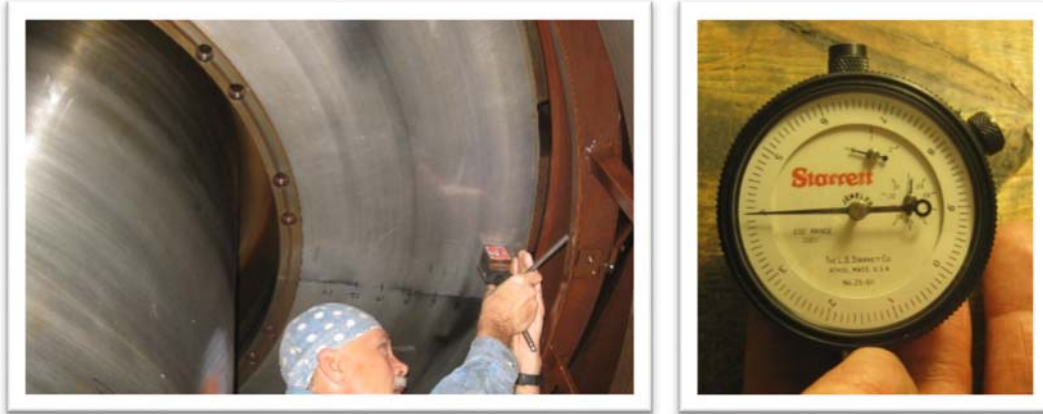
Condition of the runner plate at this time seemed to be fair. The maximum step developed at the split of the thrust bearing runner plate was 0.0003 inches. 90% of the step at each split (across both runner plate splits) was 0.0002 inches or less. This was measured using a tenth of a thousandth dial indicator.

Photo 6 & 7: Sweeping the thrust runner split with a 0.0001 inch dial indicator

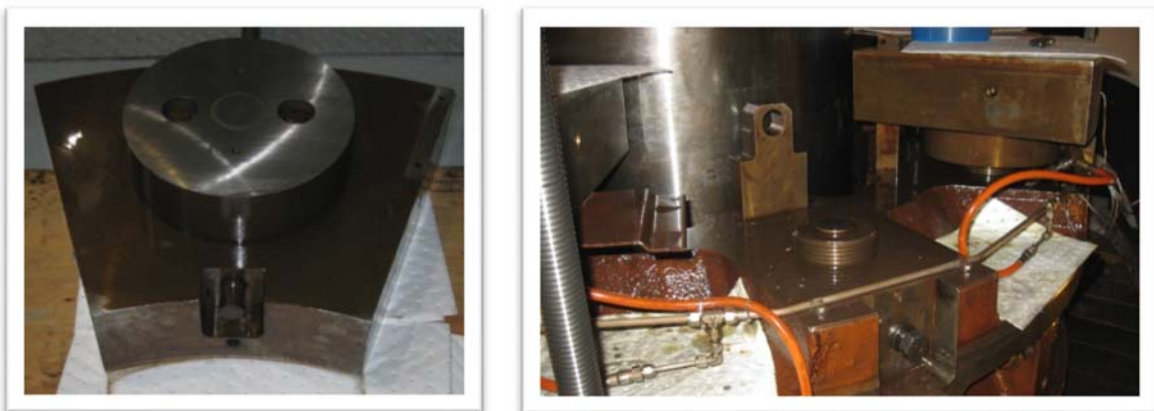
A bearing is more efficient when the pivot point is offset towards the trailing edge of the bearing. We have analyzed this Babbitt thrust bearing to have an optimal offset of approximately 65% towards the trailing edge (with 50% being the mid point of the bearing pad, 100% being the total pad). This bearing pad was originally designed with a pivot point at 50%. By offsetting the pivot point to 65%, the bearing operating temperatures will drop by a calculated value of 6 degrees Celsius.

The reason why the bearing operates cooler with the offset pivot point to the trailing edge is simple; the pivot being closer to the trailing edge softens the support under the leading edge. This allows a larger amount of oil wedge to develop at the beginning, or leading edge, of the bearing pad. Due to the larger amount of oil at the leading edge, there will be a larger amount of oil film across the entire bearing pad. When the oil film is too thin, then the thinner oil creates more heat/losses, and increases the chance of metal to metal contact.

Photos 10 & 11: Bearing support directly in the center of bearing pad

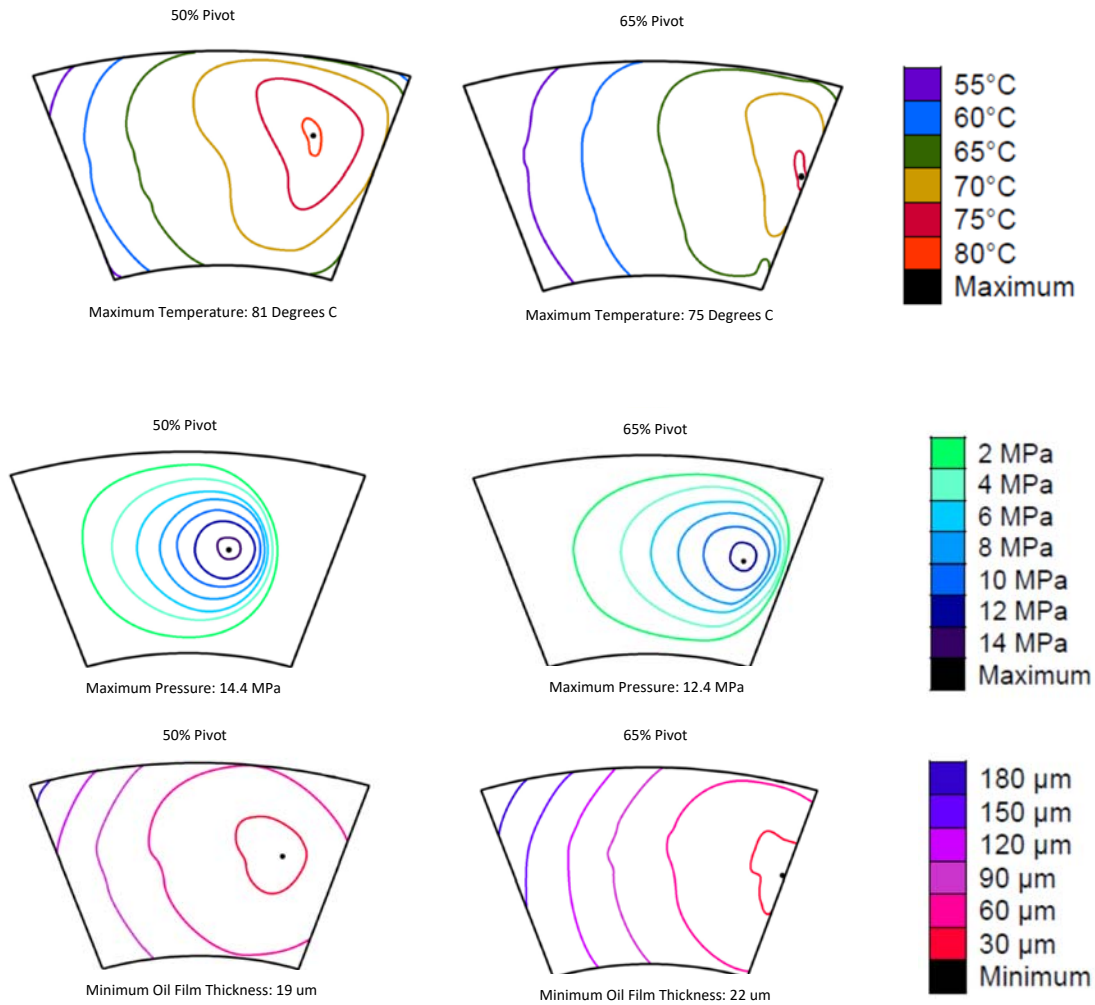
Knowing the best location for the pivot point can be easily calculated using the analysis software. Being able to shift the pivot point towards the trailing edge on a new bearing pad may be problematic. The original bearing supports do not allow the pivot point to be relocated easily. Radial, leading and trailing pad support guides are set and one can only economically modify the Babbitt thrust bearing pad itself. To obtain ideal pivot offset, the outer diameter of the bearing pad would need to be offset by 4.25 inches from its current location.

Figure 1: Babbitt bearing pad analysis results

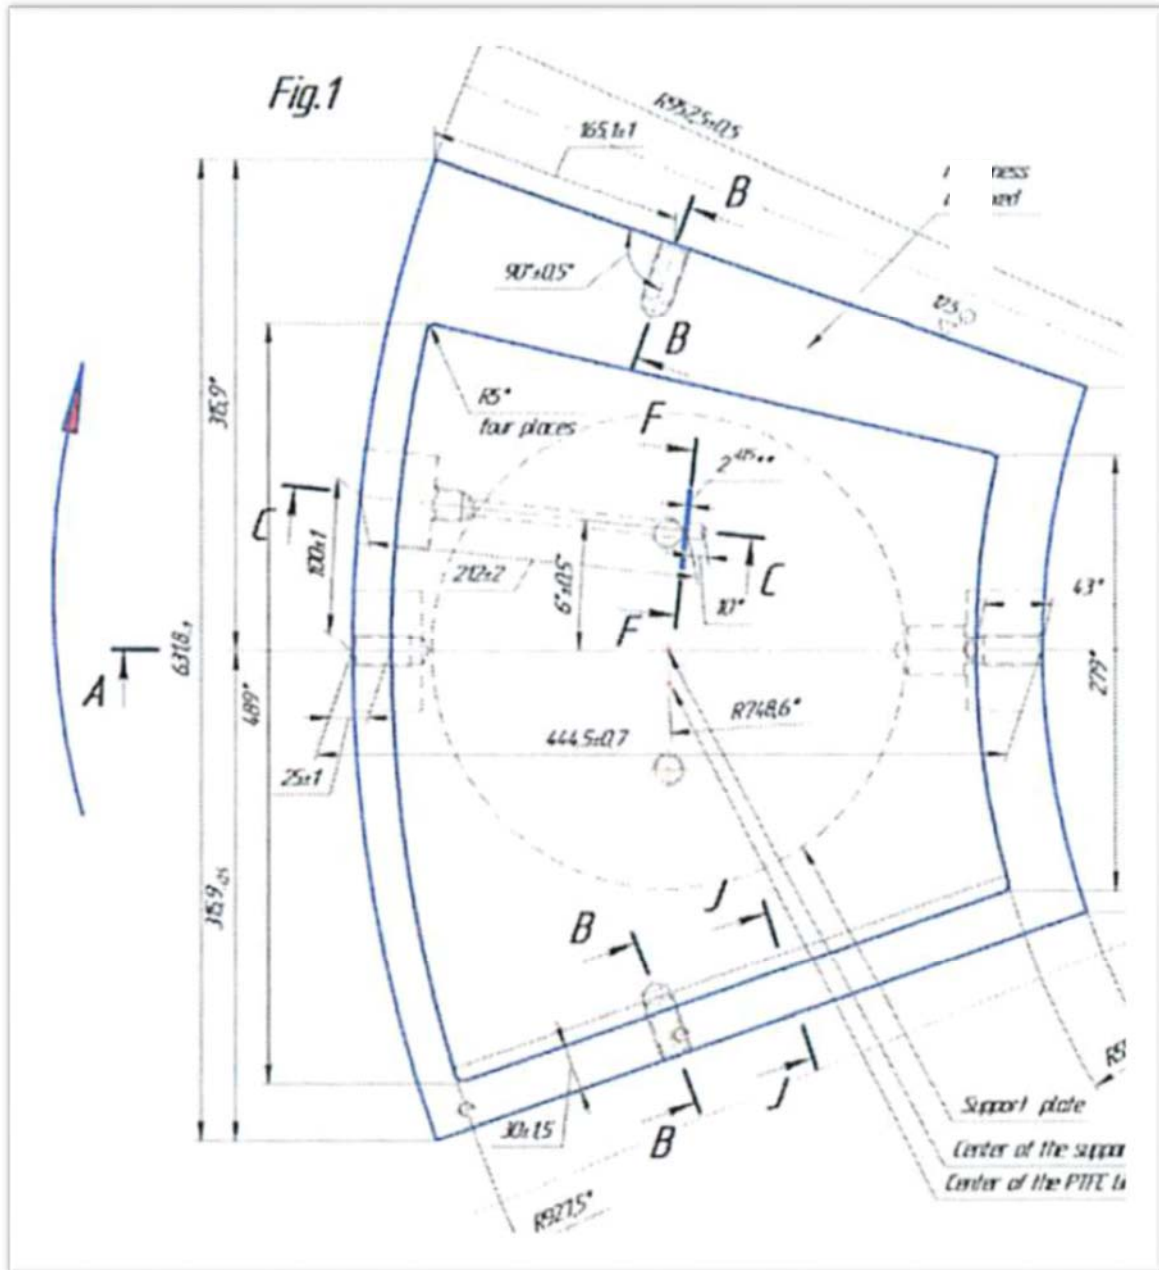
PTFE bearing pads have a different optimum pivot point as compared to Babbitt. As stated above, calculation for the original bearing offset pivot is 65%. PTFE is calculated differently due to the make up of the bearing pad structure. For this bearing, all parameters being equal, the pivot offset was only 55.5% or 5.5% from center. With this calculation, the PTFE bearing pad support offset was only 1-3/8 inches compared with the 4-1/4 inch of Babbitt bearing pad.

Figure 2: Offset of the PTFE towards the leading edge. This allows more support on the trailing edge. The dotted circle is the center pivot support. (Drawing provided by EnEnerg (Russia))

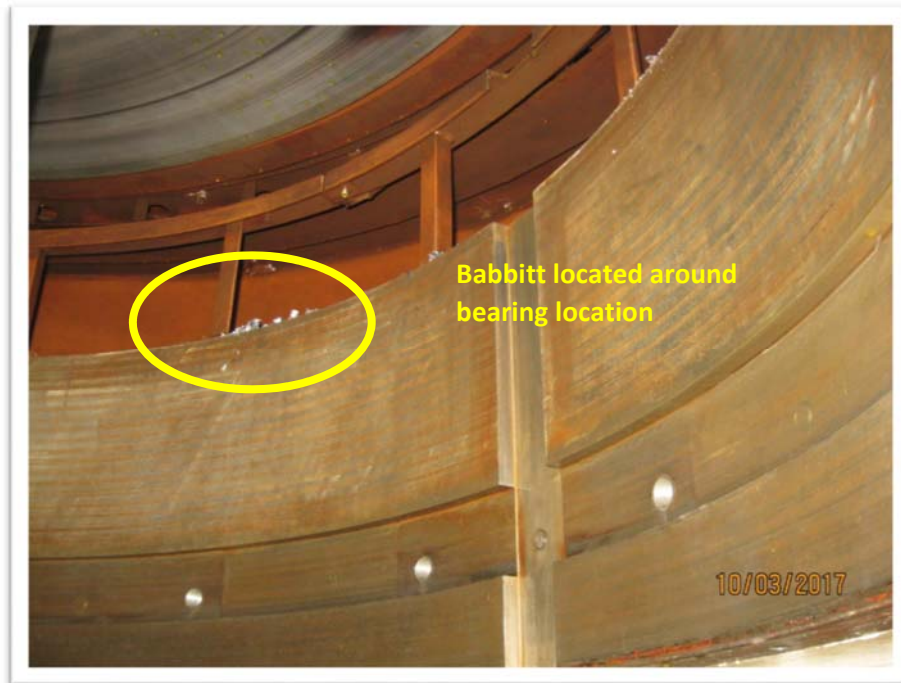
A large amount of Babbitt was found throughout the bearing pot, including large chunks up to approximately 1.5 by 2.5 inches in size. Babbitt had been dragging across the PTFE thrust bearing pads for the duration of the six-week operating time. The thrust bearing temperature did not experience a noticeable rise above regular operating temperature.

Photo 12: Babbitt in the bearing pot

The bearing pot was completely cleaned and new guide bearing pads were installed. The generator and turbine were aligned and the thrust bearing pad loads balanced. The generator is currently operating at normal capacity. Now that the oil is clean again, one can reasonably expect that the bearing still has 30 years or more of life remaining.

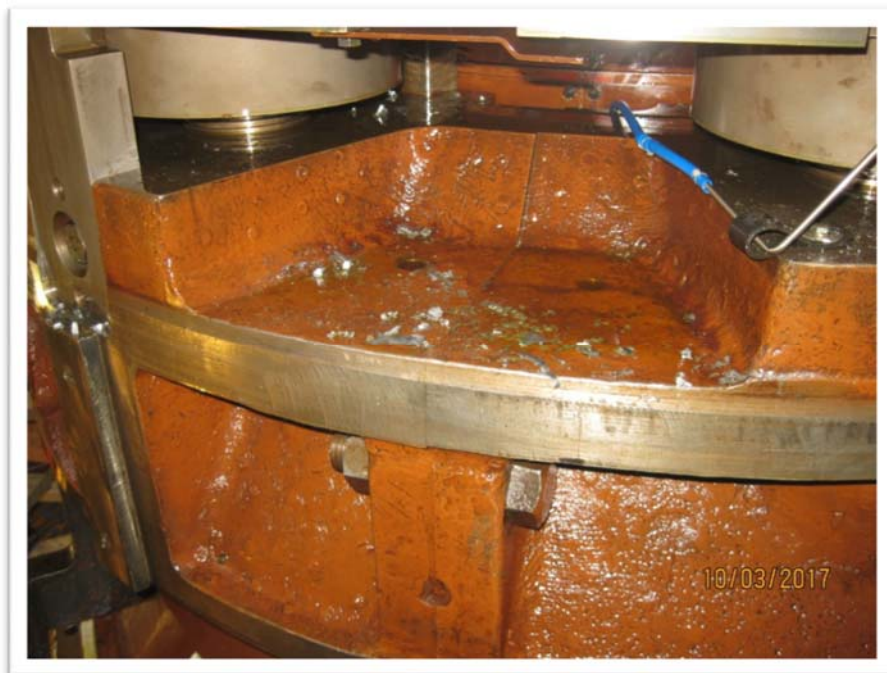
Photo 13: Babbitt chunks located on thrust bearing support base

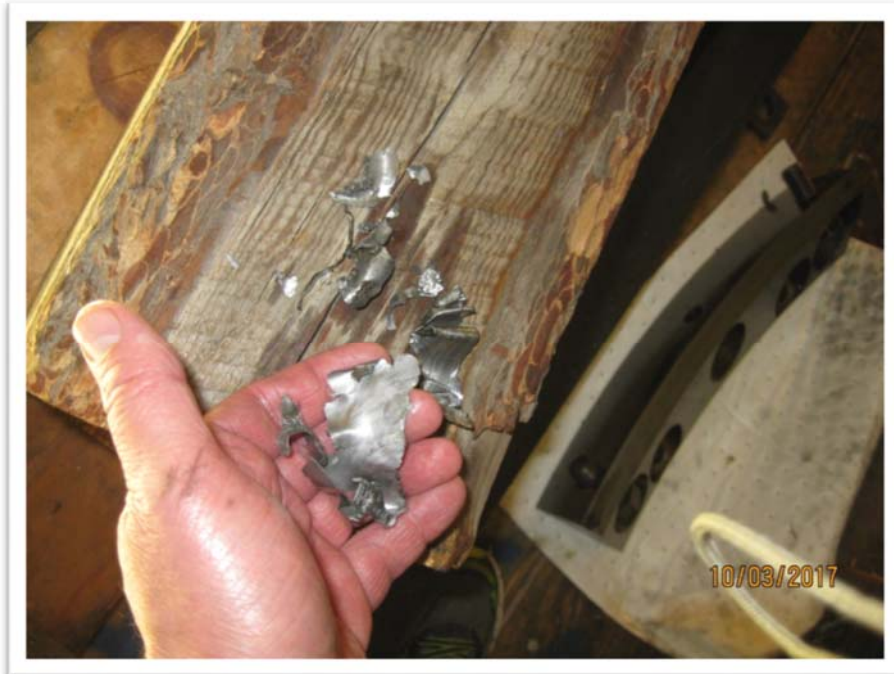
Photo 14: Babbitt removed from the bearing pot

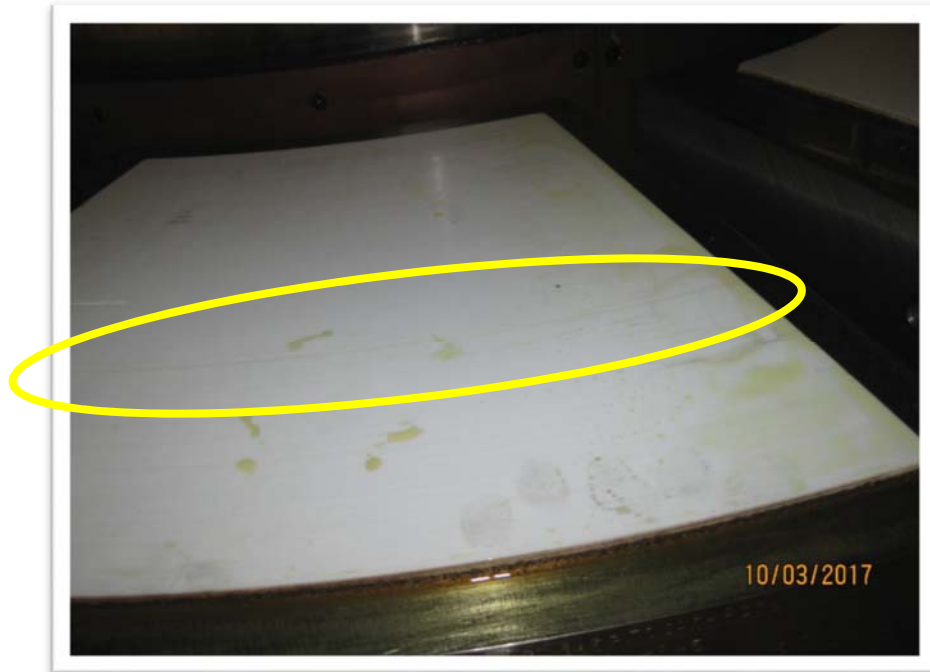
A full inspection of the thrust bearing pads was completed. There was some grooving in the PTFE, and an average of about 0.002 to 0.004 inches of material was worn away. The PTFE bearing pad has approximately 0.040 inches of PTFE above the wire mesh, therefore, approximately 5 to 10% of the bearing material was worn away.

Photo 16: Heavy grooving on PTFE surface
