Thrust Bearing Cavitation

By Mike Dupuis, Hydro Tech Inc., Canada

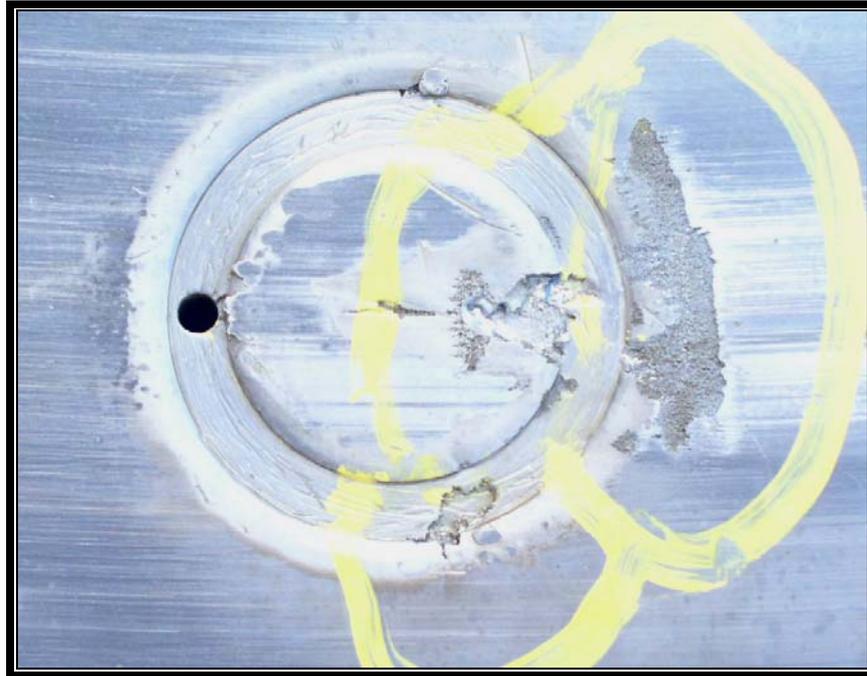
defect in the babbitt. The bearing shoes were reinstalled and operated properly until the turbine runners were upgraded years later. Cavitation was occurring throughout this time; however, the timeline during which significant damage would occur was actually much longer. Thrust bearing cavitation was not significant until after the turbines were upgraded from 135 MW to 170 MW (Photo 1).

Photo 1
High Pressure Lift Port Cavitation

Of further concern, due to increased load on the thrust bearing, the bearing now operates much closer to its ultimate load limits. Photo 1 shows that, in addition to the cavitation, signs of metal-to-metal contact are visible in the presence of slight wiping indications. Small wiping and grooving is evident at the left side of the high pressure oil lift (HPOL) port circle; this indicates that the bearing is overloaded. Prior to the bearing redesign, the generator had to be operated at reduced loading during the warmest time of the year to prevent the bearing from overheating and “wiping”.

The runner plate segments have a gap between them ranging from 0.7mm to 3.2mm. This creates a void in which oil pressure between the stationary bearing pads and the rotating runner plate can disappear. Prior to the turbine upgrade, the thrust bearing operated without incident due to lower average pressures on the bearing. With the increased thrust, the oil film between the babbitt thrust pads and thrust runner plate has decreased, while the average pressure has increased. Because of increasing the pressure drop at the thrust runner plate split, as well as increasing its subsequent effect on the babbitt due to close proximity, the bearing began showing signs of thrust shoe cavitation pitting. This pitting first became evident in the area of the HPOL outlet (Photo1).

Cavitation results from pressure drops, usually in an unloaded (low pressure) area where pressure can change to slightly below atmospheric pressure. In this particular case, the average pressure is 3.8 Mpa; however, some areas are more loaded than others. Generally, a higher load area is located in the middle of the bearing pad surface toward the trailing edge, close to where the HPOL ports are. The HPOL port is where the most significant pressure drop occurs due to a change in oil film thickness (step in the babbitted surface).

As the runner plate passes over the babbitted stationary surface, particularly the HPOL ports, pressure drops dramatically. This creates turbulence causing oil film breaks that disperse dissolved gases and, possibly, oil vapours. Thus, cavitation begins.

The most viable option for addressing the cavitation and overloaded condition of this thrust bearing assembly requires two steps: (1) A new segmented runner plate correctly manufactured, then bolted and keyed together making one complete ring after installation, This would create an improved running surface for the bearing, eliminating spaces for oil pressure to vacate from the bearing surface. (2) Changing

the babbitted bearing pads to high capacity PTFE bearing pads able to provide additional thrust support.

A new bolted and keyed runner plate was designed to prevent cavitation from forming on the bearing pads. PTFE bearing pads were supplied to replace the babbitted bearing pads, thereby providing double the thrust load carrying capabilities.
