## A Case Study of an S-Turbine Seal Failure

By: Michael Detenbeck, P. Eng., Hydro Tech Inc.

Site: Energy Ottawa New York, Dolgeville Generating Station

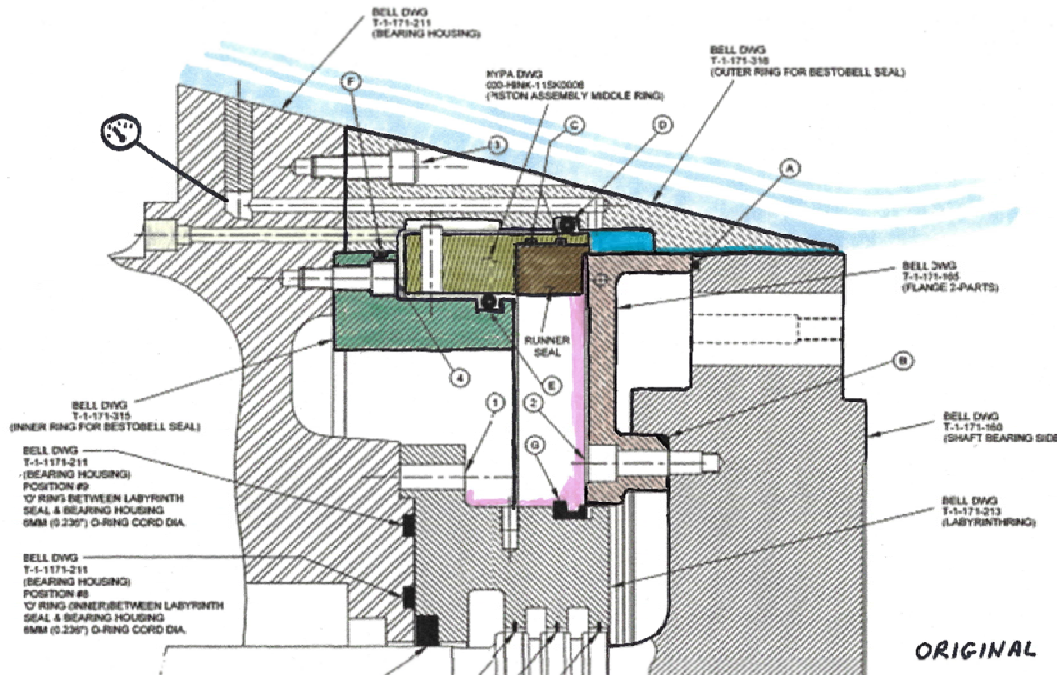
Figure 2 - Original

The designers relied upon lubricating and cooling the seal face by extracting penstock water. While economical in the first instance, any blockage of flow would cause the seal element to contact the thrust face, heat up and wear prematurely. River silt would create grinding action between the contact faces and could plug up the passageways.

Water ports to positively lubricate the seal were not designed into the stationary bearing housing as space for this was not readily available. The original engineering process relied on large clearances between the runner shaft and the outer seal ring, thus allowing river water to pass over the runner shaft flange, under the seal ring, across the seal face, and into the drain. Under start-up conditions, and during episodes with high particle counts in the water, one can see how quickly the seal contact face can lose lubrication and cooling.

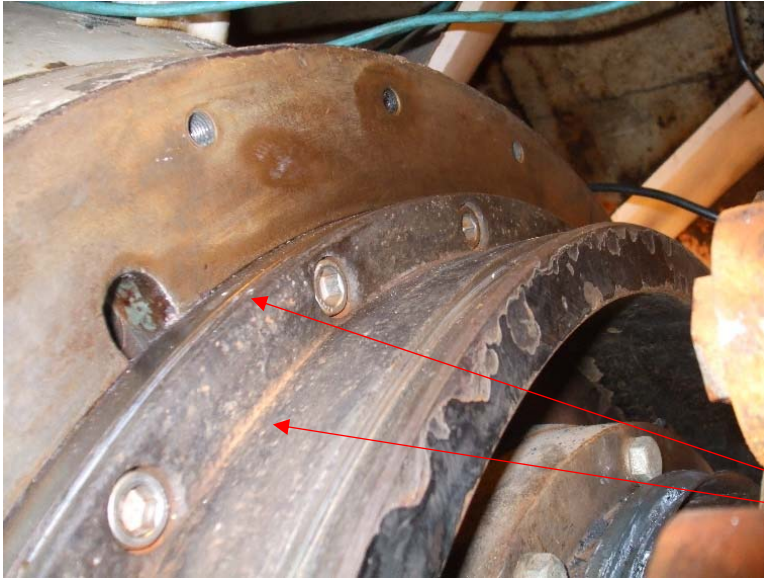
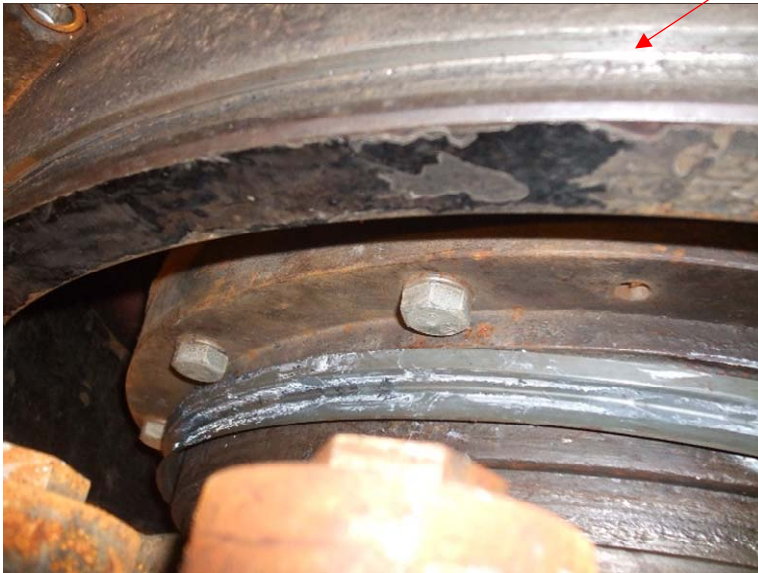
**Photos 2a & 2b: Inner seal ring cleaned and installed**

Note:  
pitting on  
working  
surfaces

Imagine this part having water sit stagnant in the O-ring groove and on the outer surfaces where the piston slides. Corrosion will always be the enemy here, eating away at the O-ring lands and binding up the movement of the piston.

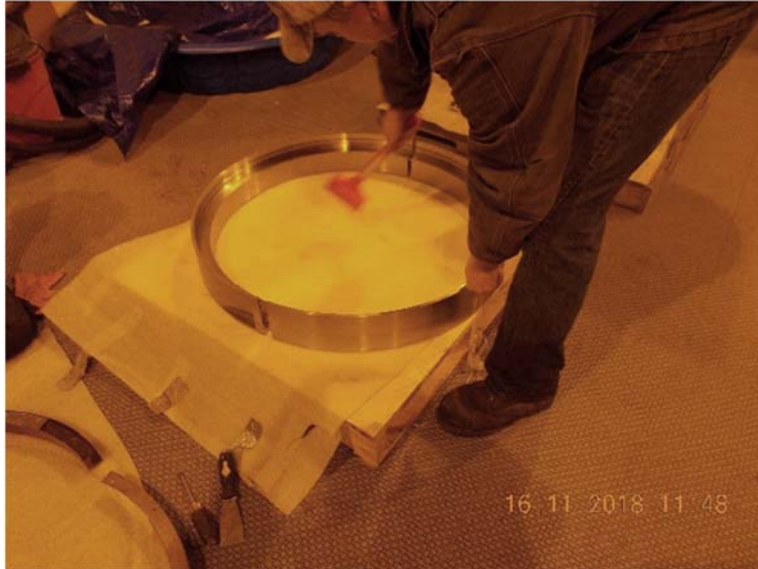
**Photo 3: Trial fitting piston before installing**

The piston was also of split construction and it relied on an outer O-ring and an inner O-ring to maintain seal pressure. Unfortunately, the O-rings are offset and create a cantilever beam that allows the piston to bend slightly, enough to relieve the pressure on the outer O-ring which, in turn allows water to escape and pressure to drop. The split made it hard to install the O-rings without creating a leakage path or pinching. This combined with trying to glue the O-rings and not get lubricating grease in the bonding area, was extremely difficult.

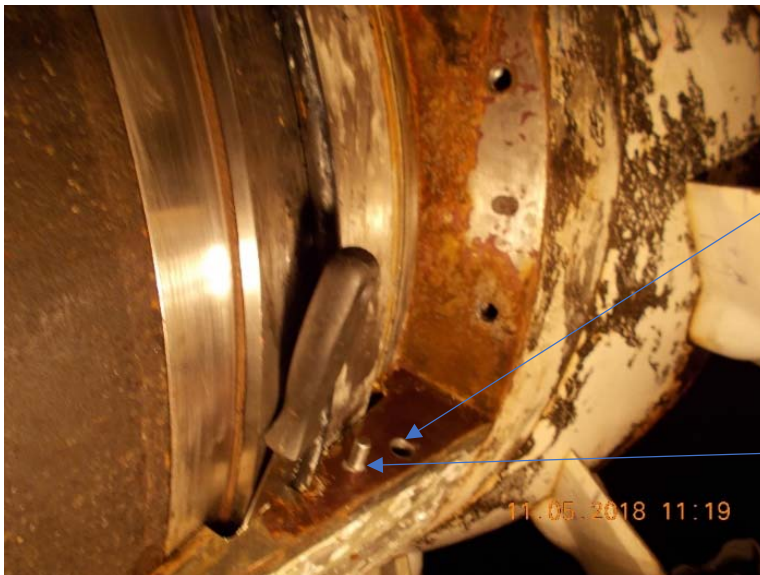
Photo 4: Lower half of outer seal cover

The outer seal cover was split and tapered in a shape that eliminated the possibility of equalized clamping across the face. There was only one pair of bolts holding the halves together and it was near the mounting flange at the bearing housing. On our first visit, it was noted that this cone was twisted on the centreline axis. Inspections later verified it was out of alignment front and back by 0.6 mm. This was caused by the seal grabbing the outer seal housing and causing it to open and distort at the split line.

Clamping bolt location

Dowel

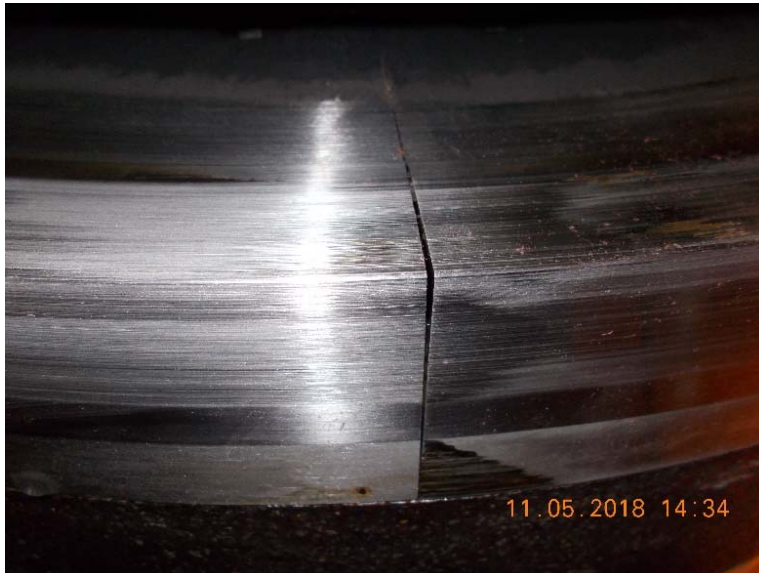
Also, noteworthy, once the seal material started to wear, the material started to gall the seal steel face material. One should note that the damaged originally polished steel is now acting as a grinder on the seal.

**Photo 5 – Gap and sharp edges act as a scraper on the seal element**

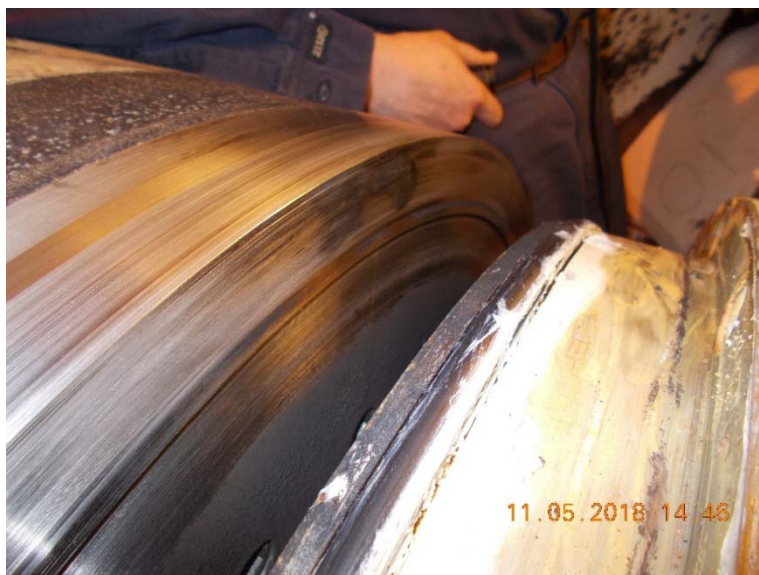
**Photo 6: Burn marks on thrust flange.**

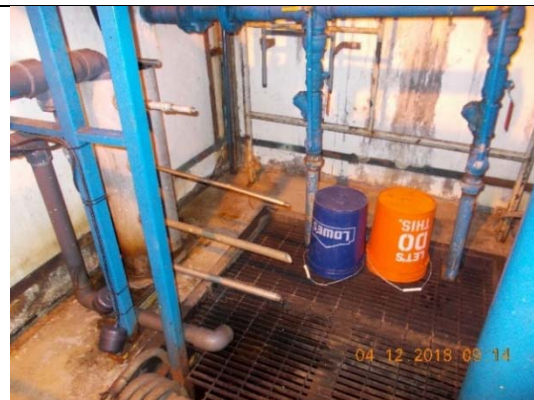
**Photo 7: Seal water flow indicators**

Records of commissioning commencing from 20 June 2017 were available. A turbine specialist company was hired to do the work and provided an aftermarket seal element. This seal element was installed and immediately began to overheat and smoke. The unit was shut down on 21 June 2017 without going on-line. The unit was re-started at a restricted speed of 50% during no-load conditions and put on-line. On June 25 a leak arose in the lower stay vane area (*Figure 5*). It turned out that the seal had fragmented and was clogging the water drain (*Photo 7*).

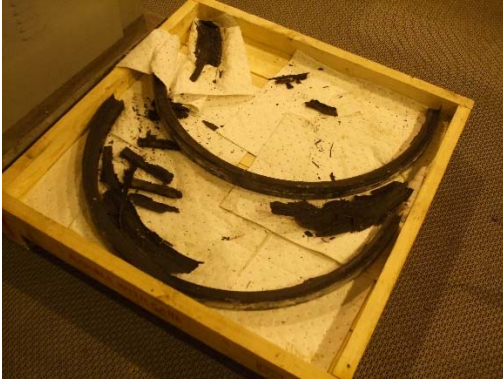
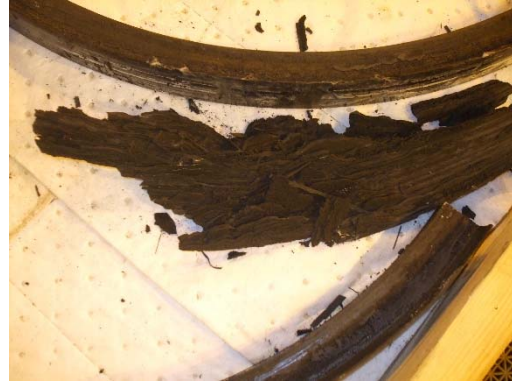
**Photos 8 & 9: Failed aftermarket seal 2017**

In October 2017 another attempt to start the turbine/generator unit occurred. The first seal melted at 25% loading of the generator. A second seal was installed but lasted only 2 minutes and 57 seconds.

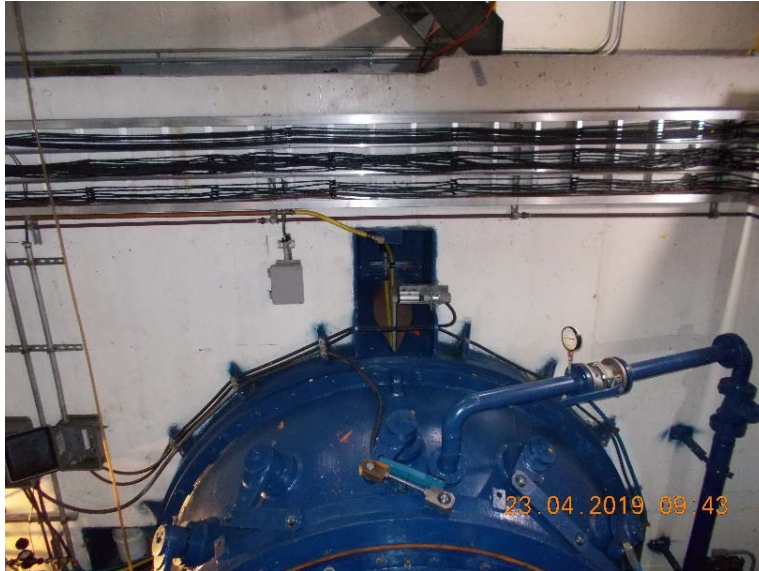
Photo 10: Turbovent piping

The turbovent was designed as a 3" vent line. As this line may be subjected to a full vacuum (30" HG or up to 30 psi), it was fitted with a shut-off ball valve, a sinking ball check valve, a silencer and a strainer basket. Its purpose was to feed station air into the water stream during start-up automatically and on demand.

We installed a turbovent to provide air into the distributor housing which would relieve any vacuum pressure that could occur during start-up or shut down. We set up the draft tube pressure gauge on this piping.

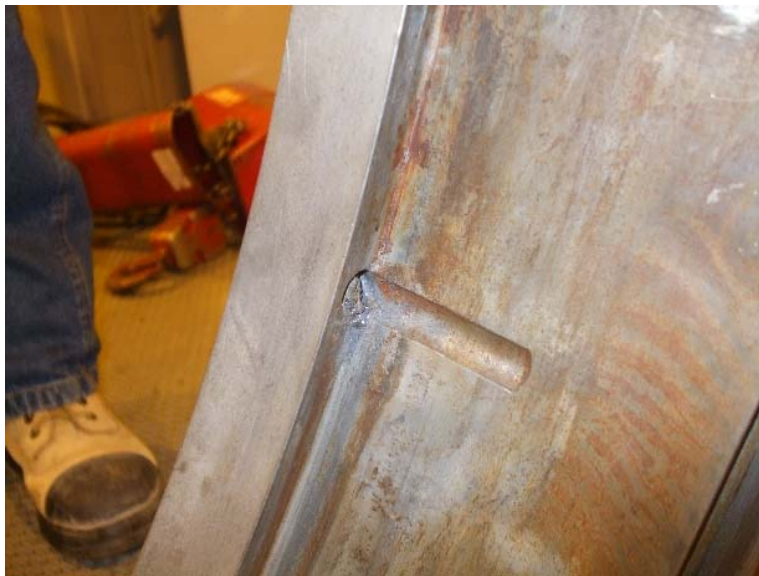
It was noted that when the seal wears and the piston is extended, it closes off the opening to the old pressure port. As we were using this port to provide water, we modified the outer seal ring by cutting in a slot and closing the clearances by adding a bronze band. In hindsight, it turns out that when the piston closed over this port, when in original factory condition, a vacuum was occurring that was being read as negative penstock pressure.

**Photos 13: Blocked pressure monitoring port**

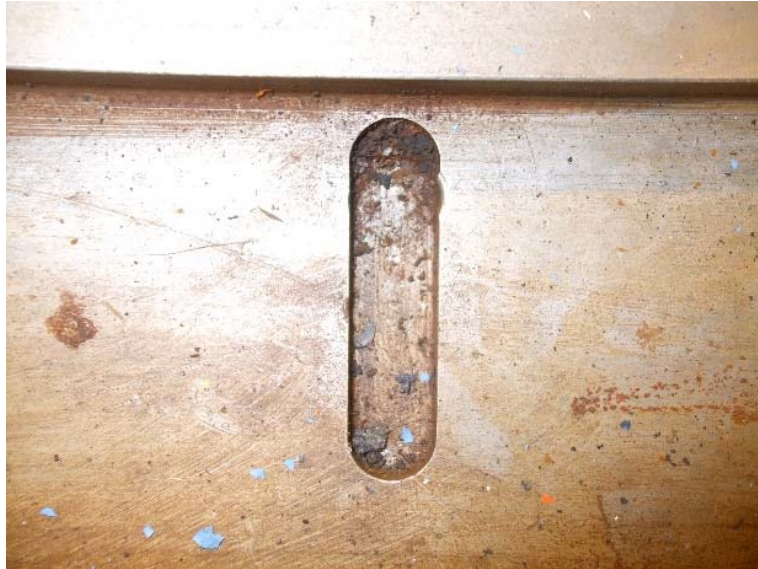
**Photo 14: Damaged slot for anti-rotation pin**

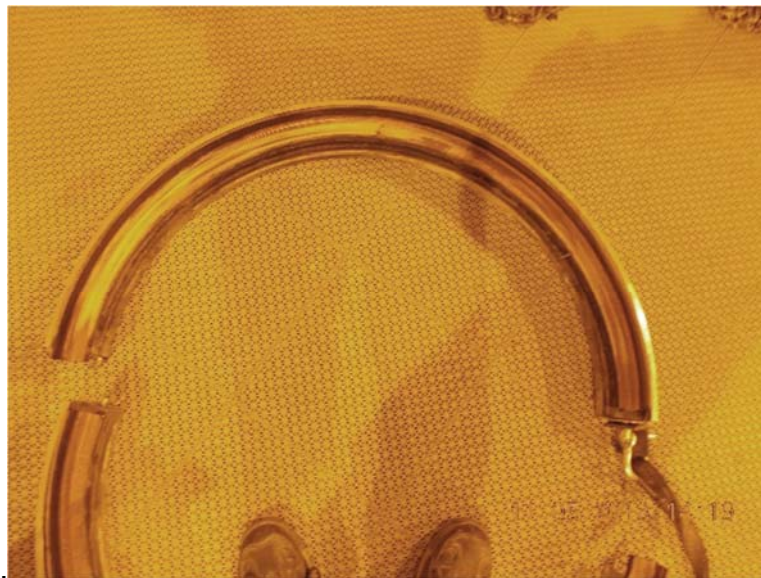
On 3 May 2018 the seal assembly work was completed, and the unit commissioned for start-up. Within 4 days (7 May 2018), the seal had worn down to 3 mm remaining and the turbine shut down.

**Photo 17: Worn L/D seal element in piston**

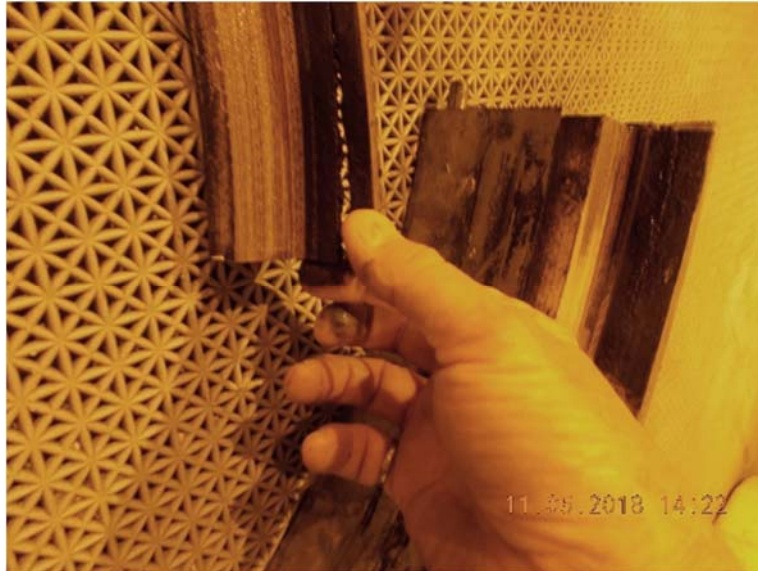
**Photo 18: Worn L/D seal element after removal from piston**

- The 304 stainless steel flange ring was replaced with 400 series stainless steel, heat treated to give better wear properties.
- We replaced the Bestobell element with a natural fiber wood (Lignum Vitae), which has much better properties for sealing on rotary faces and complements the choice of 420 or 410 stainless steel. Lignum vitae is a wood that has natural lubricating properties. While Lignum Vitae should always be kept wet, it is able to self-lubricate should water lubrication and cooling conditions be marginal.

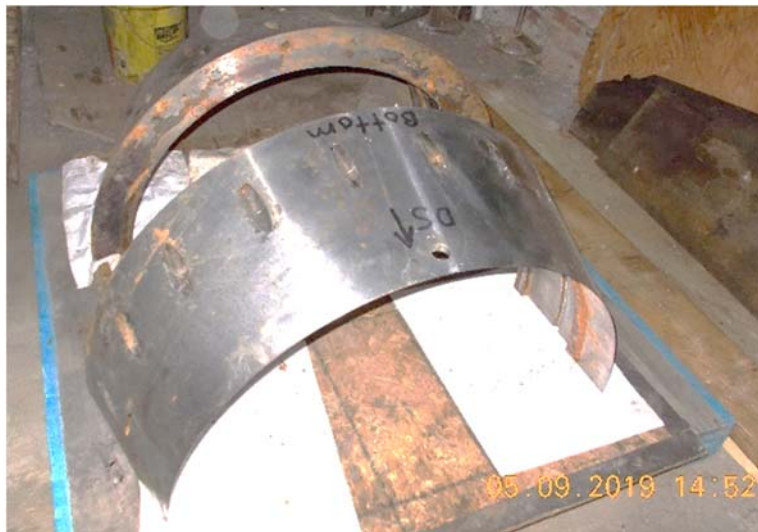
Photo 26: Outer seal cover with no evidence of twisting or pick up

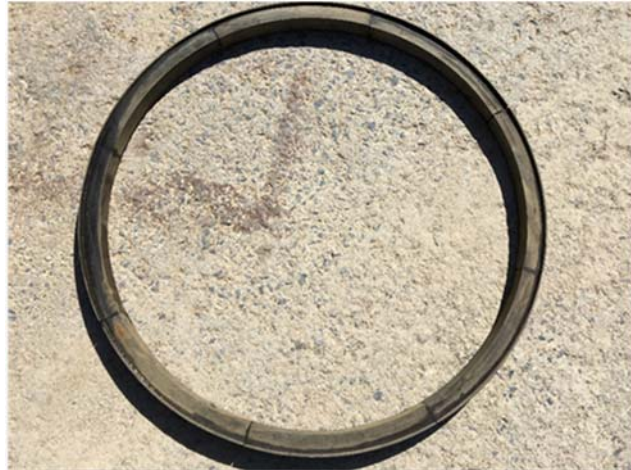
Successful trials with over twenty stop and start events and over 1400 hours of operation have shown very little break-in wear (<0.08”) and the remaining thickness of the seal element has not changed after break-in. This break-in period occurred within the first month of operation with little to no wear after.

Photo 27: Lignum Vitae seal after 1400 hours operating time
