KERR GS THRUST BEARING REPLACEMENT

Gary Peterson, Maintenance Manager, *Energy Keepers Inc.* USA

Mike Dupuis, President, *Hydro Tech Inc.* Canada

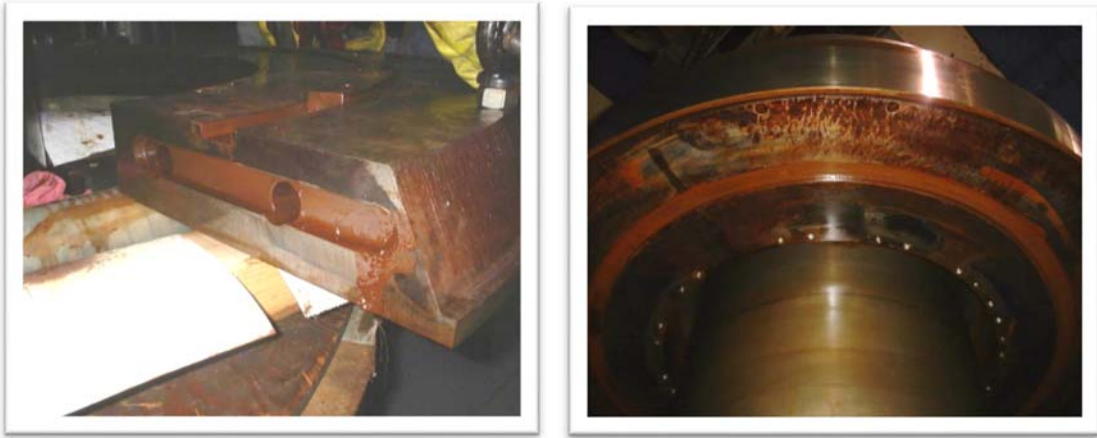
Significant fretting was found between the runner plate and the thrust block. As well, the thrust runner plate mounting surface was severely worn with fretting. Fretting was so extensive between the runner plate and thrust block, and at the split runner plate key, that all surfaces required machining to remove excessive amounts of material (Photos 1 & 2). More than 0.040 inches was removed from both the thrust runner plate and the thrust block to restore tolerances. The thrust bearing pads were re-Babbitted during the overhaul/turbine upgrade.

Photos 1 & 2: Fretting at the runner plate split key and the thrust block mounting face 2006

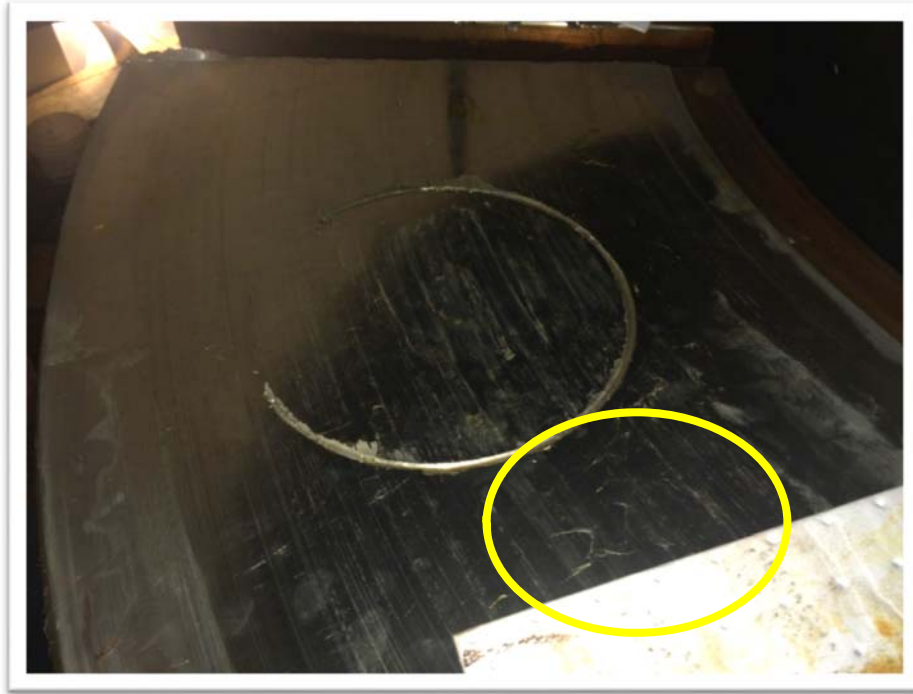
In 2014, the thrust bearing wiped when a loss in station service caused the oil lube pump to fail. The bearing was replaced without a thorough inspection of the thrust bearing pads as the root cause was the oil lube pump. However, in hindsight, it appears that defects may have been developing in the form of cracks in the Babbitt. One can see the presence of possible cracking on the Babbitt bearing pads in the area in front of the lift pump (Photo 3).

Photo 3: Bearing wiped. Potential cracking on Babbitt pad

The thrust bearing pads were re-Babbitted, installed, and a full turbine/generator rotational alignment was completed, including balancing of the thrust bearing pads.

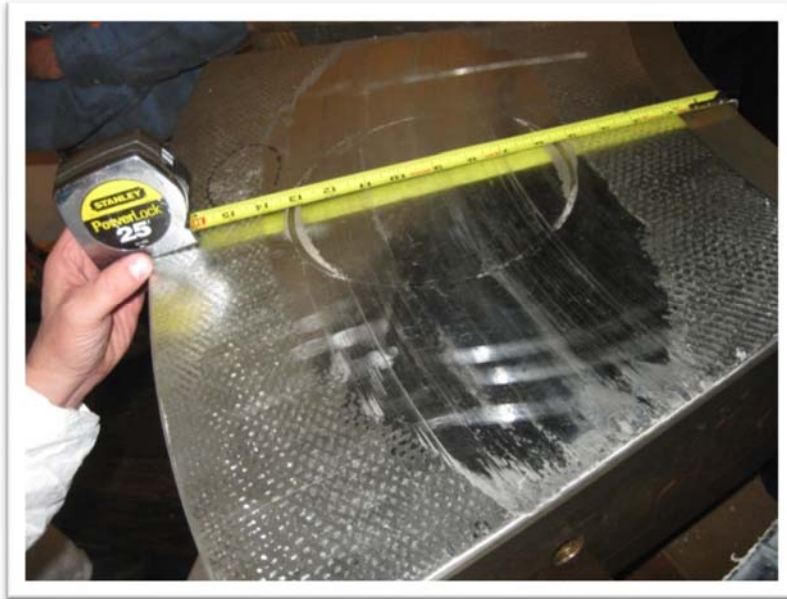
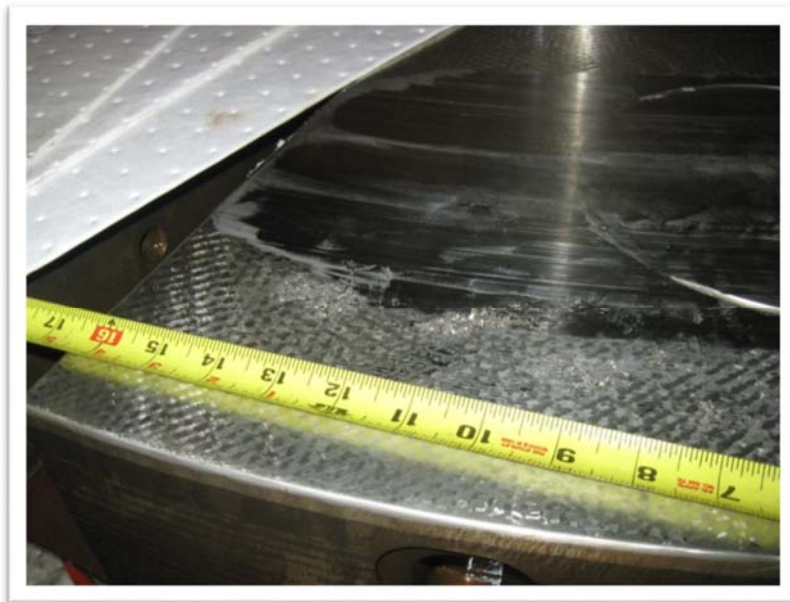
A definitive cause of this thrust bearing failure was a cooling water failure and a contributing factor was that the temperature shutdown was also set too high. The overly elevated setting of the temperature shutdown was implemented due to the elevated operating temperatures normally encountered. This elevated setting did not allow an adequate safety factor to prevent damage to the bearing. However, when the thrust bearing was disassembled, cracking at the outer trailing portion in the Babbitt was also noted on all eight (8) bearing pads. Some of the Babbitt in the cracked Babbitt pieces appeared to be missing. It is possible that some Babbitt had become loose, and that a small fragment of Babbitt had lifted and initiated the bearing wipe.

Inspection of the thrust bearing pads found the cracking and defects to have occurred on each of the eight bearing pads in the same location. Defects were consistent on each pad in appearance, having a size of about 2 inches by 3 inches (Photos 4 & 5). The cracking was also located close to the wiped areas on the thrust pads. It is possible that additional cracking was within the wiped area of the thrust pad, but was now covered with the smeared Babbitt. As noted in the 1977 failed thrust bearing report, the cracking was again located towards the trailing edge on the outer diameter of the thrust bearing pad.

Photo 4: Wiped thrust bearing

Photo 5: Wiped thrust bearing

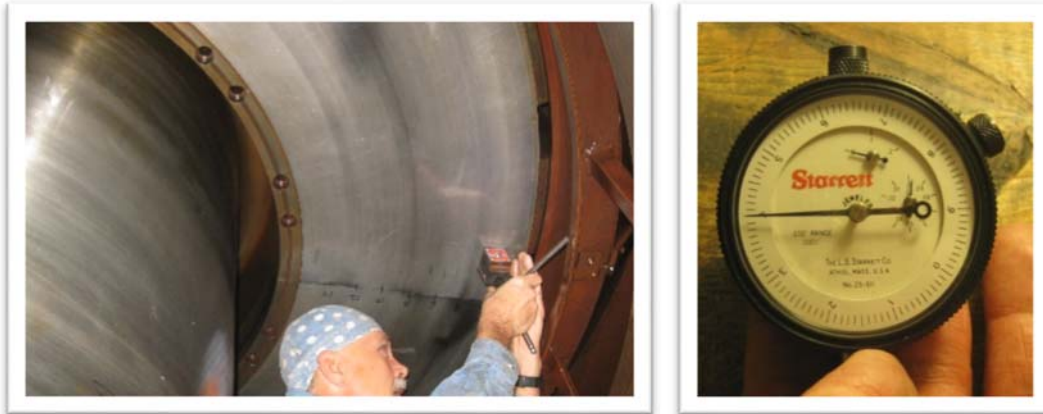
Condition of the runner plate at this time seemed to be fair. The maximum step developed at the split of the thrust bearing runner plate was 0.0003 inches. 90% of the step at each split (across both runner plate splits) was 0.0002 inches or less. This was measured using a tenth of a thousandth dial indicator.

Photo 6 & 7: Sweeping the thrust runner split with a 0.0001 inch dial indicator

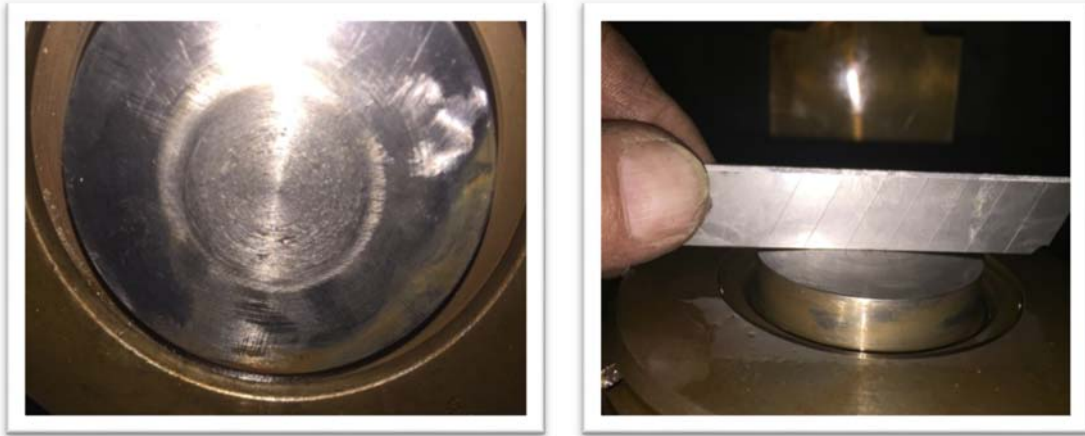
The thrust bearing pad load cells were inspected and found to have damaged top crown surfaces. After much consultation, the cause of damage remained undetermined. There seemed to be pitting on the load cells, surface roughness was recorded to be as high as 96 Ra. Repair was required as these load cells are used to plumb the generator, and to balance loading of the thrust pads. The rough surface of the load cells would certainly flatten over time, causing the loading to vary from thrust pad to thrust pad. Even though the surface polish was certainly out of specification, the hardness test remained in specification at a Brinell hardness of 430, or better.

Photos 8 & 9: Damaged load cells. Large amounts of pitting had formed on the top surface.

It was decided that the surface finish of the load cells must be corrected as the load cells could not be used in their current condition. To polish and rework the current load cells, the outage duration would have been extended. New, stock load cells were sourced and purchased. This allowed freshly calibrated load cells to be installed within days.

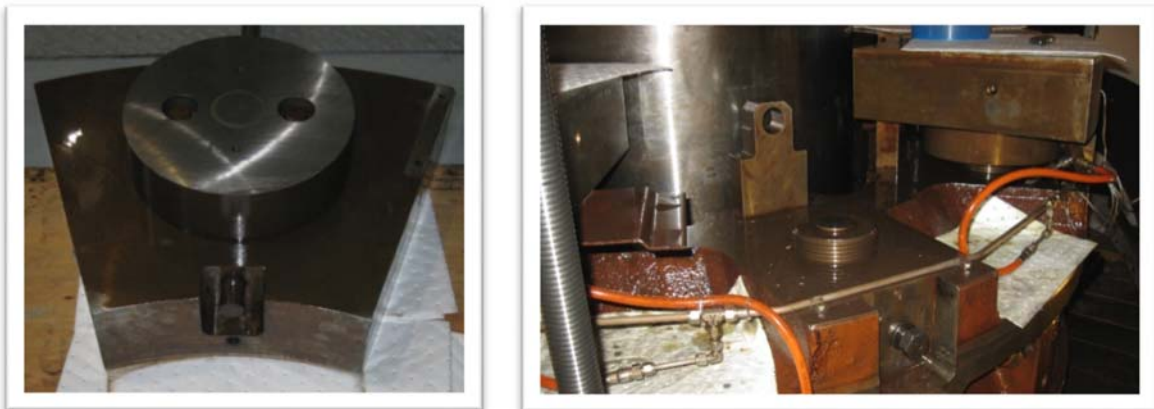
A bearing is more efficient when the pivot point is offset towards the trailing edge of the bearing. We have analyzed this Babbitt thrust bearing to have an optimal offset of approximately 65% towards the trailing edge (with 50% being the mid point of the bearing pad, 100% being the total pad). This bearing pad was originally designed with a pivot point at 50%. By offsetting the pivot point to 65%, the bearing operating temperatures will drop by a calculated value of 6 degrees Celsius.

The reason why the bearing operates cooler with the offset pivot point to the trailing edge is simple; the pivot being closer to the trailing edge softens the support under the leading edge. This allows a larger amount of oil wedge to develop at the beginning, or leading edge, of the bearing pad. Due to the larger amount of oil at the leading edge, there will be a larger amount of oil film across the entire bearing pad. When the oil film is too thin, then the thinner oil creates more heat/losses, and increases the chance of metal to metal contact.

Photos 10 & 11: Bearing support directly in the center of bearing pad

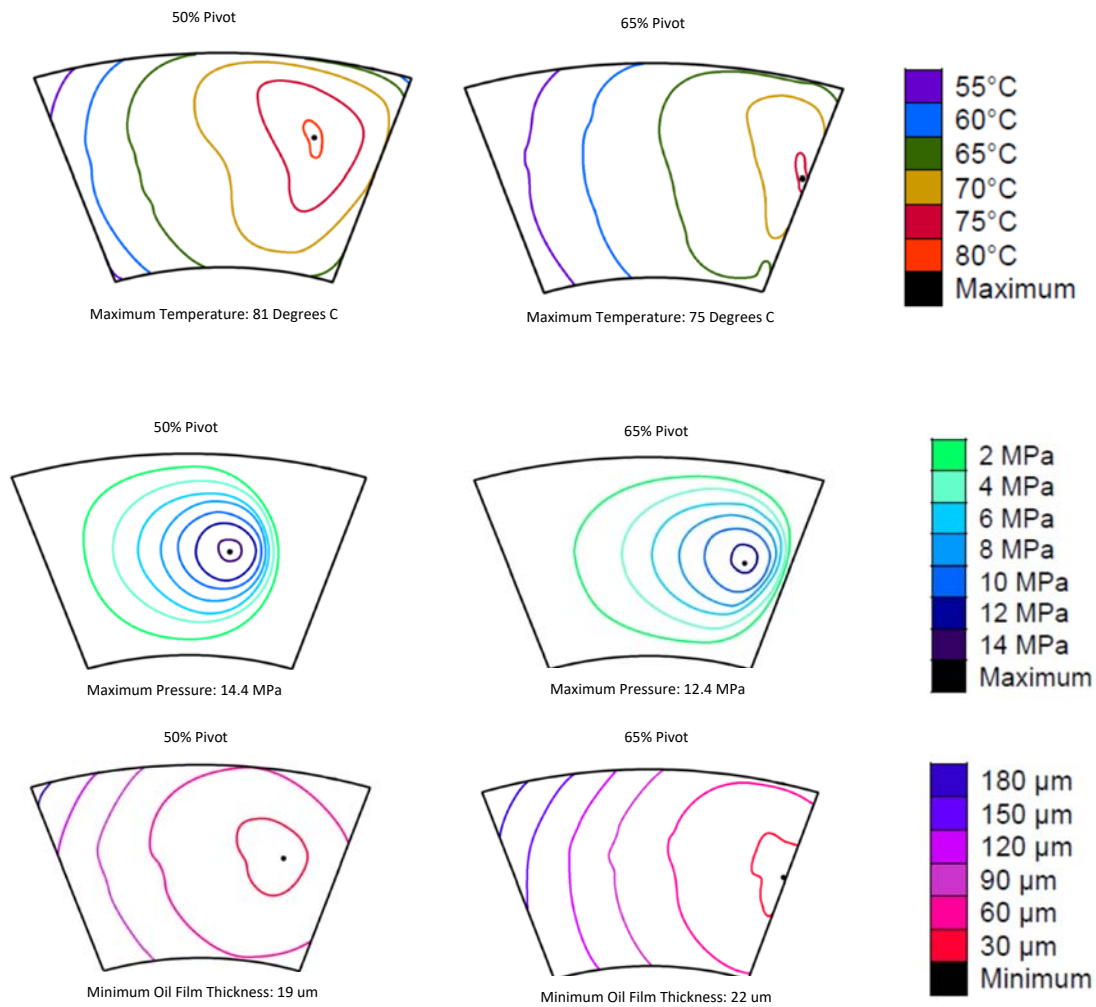
Knowing the best location for the pivot point can be easily calculated using the analysis software. Being able to shift the pivot point towards the trailing edge on a new bearing pad may be problematic. The original bearing supports do not allow the pivot point to be relocated easily. Radial, leading and trailing pad support guides are set and one can only economically modify the Babbitt thrust bearing pad itself. To obtain ideal pivot offset, the outer diameter of the bearing pad would need to be offset by 4.25 inches from its current location.

Figure 1: Babbitt bearing pad analysis results

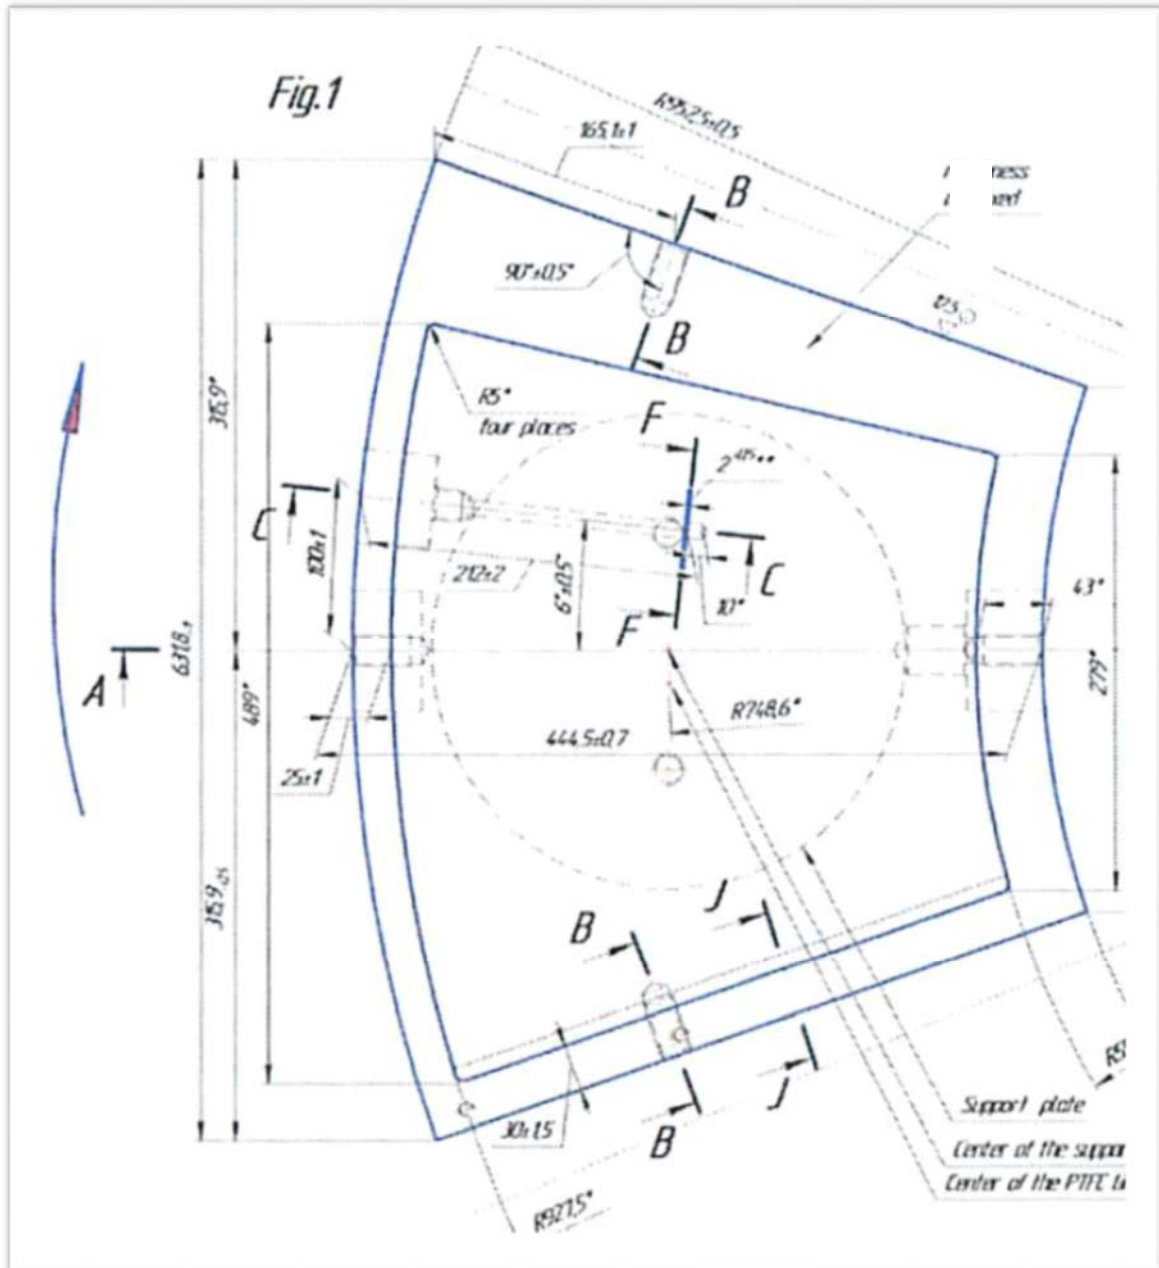
PTFE bearing pads have a different optimum pivot point as compared to Babbitt. As stated above, calculation for the original bearing offset pivot is 65%. PTFE is calculated differently due to the make up of the bearing pad structure. For this bearing, all parameters being equal, the pivot offset was only 55.5% or 5.5% from center. With this calculation, the PTFE bearing pad support offset was only 1-3/8 inches compared with the 4-1/4 inch of Babbitt bearing pad.

Figure 2: Offset of the PTFE towards the leading edge. This allows more support on the trailing edge. The dotted circle is the center pivot support. (Drawing provided by EnEnerg (Russia))

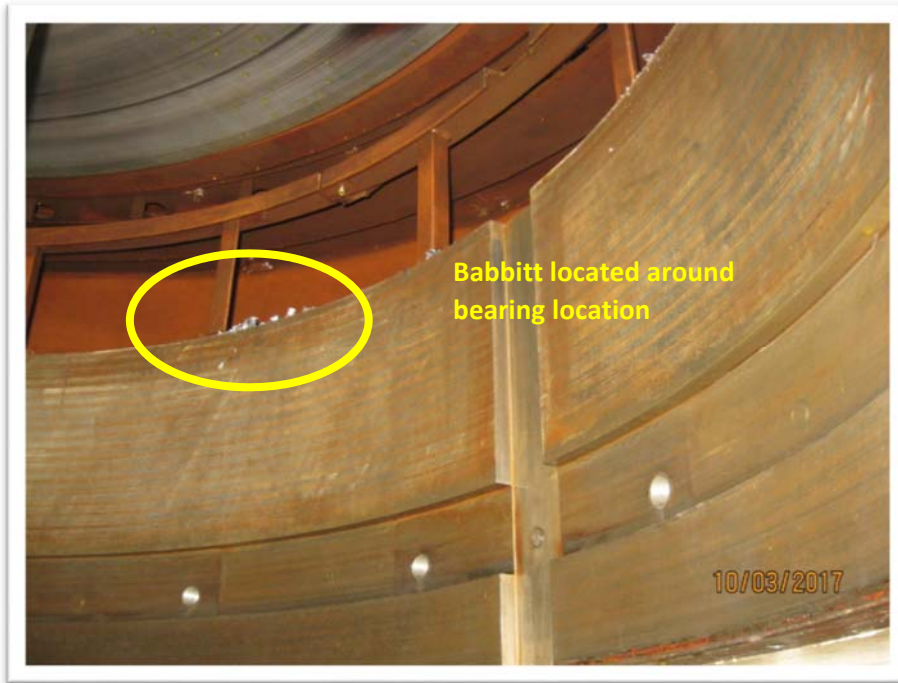
A large amount of Babbitt was found throughout the bearing pot, including large chunks up to approximately 1.5 by 2.5 inches in size. Babbitt had been dragging across the PTFE thrust bearing pads for the duration of the six-week operating time. The thrust bearing temperature did not experience a noticeable rise above regular operating temperature.

Photo 12: Babbitt in the bearing pot

The bearing pot was completely cleaned and new guide bearing pads were installed. The generator and turbine were aligned and the thrust bearing pad loads balanced. The generator is currently operating at normal capacity. Now that the oil is clean again, one can reasonably expect that the bearing still has 30 years or more of life remaining.

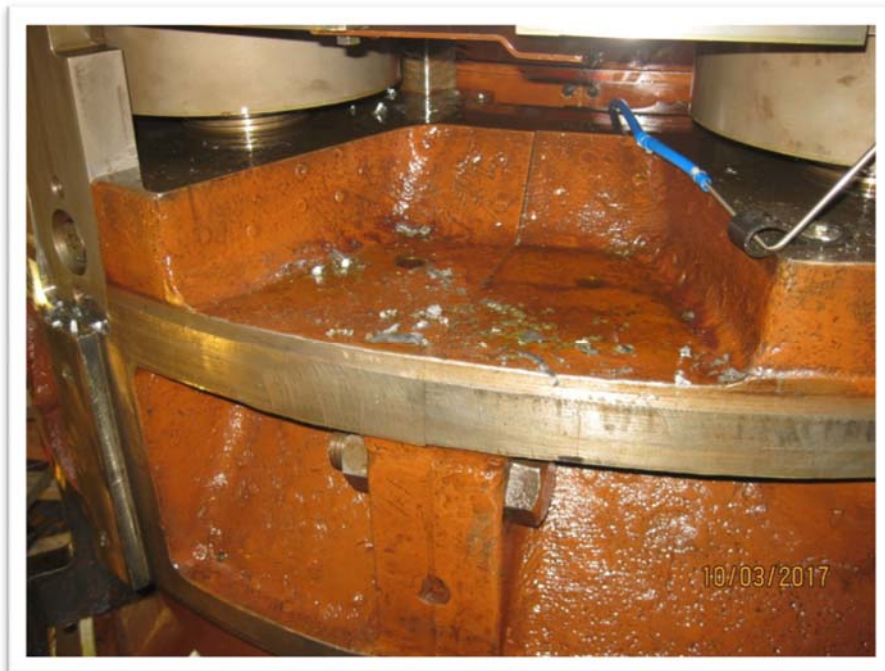
Photo 13: Babbitt chunks located on thrust bearing support base

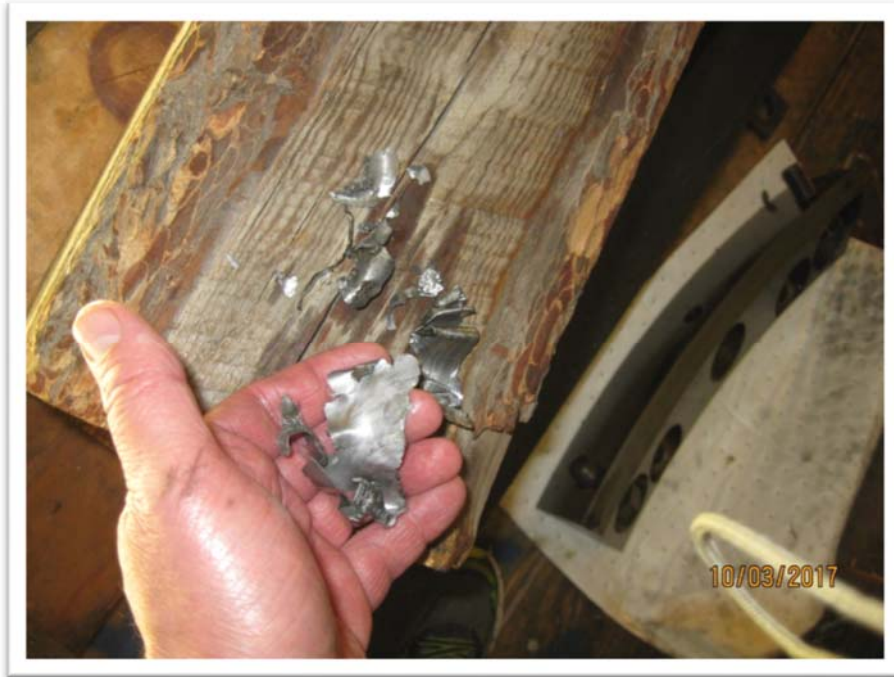
Photo 14: Babbitt removed from the bearing pot

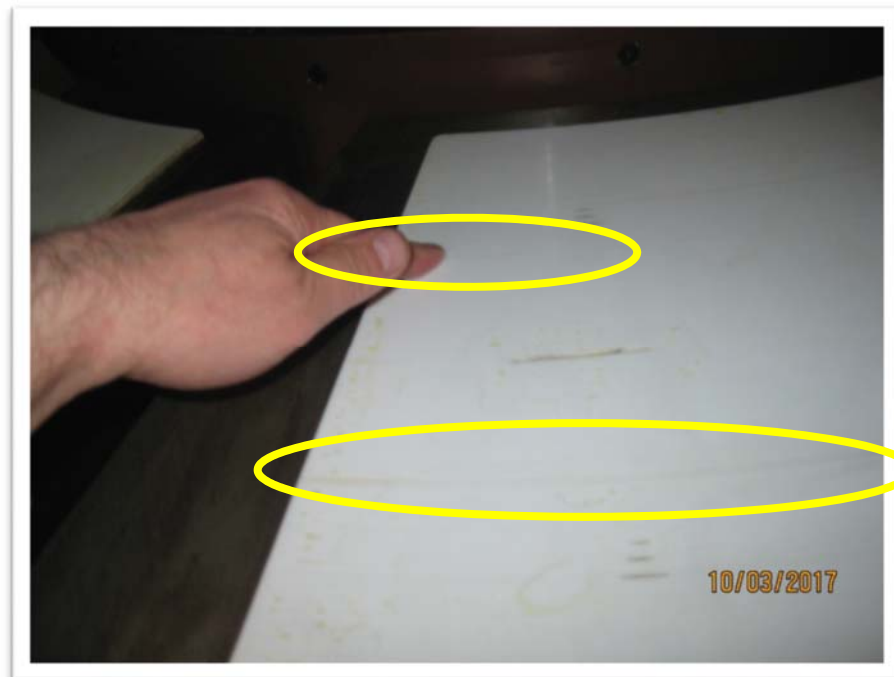
A full inspection of the thrust bearing pads was completed. There was some grooving in the PTFE, and an average of about 0.002 to 0.004 inches of material was worn away. The PTFE bearing pad has approximately 0.040 inches of PTFE above the wire mesh, therefore, approximately 5 to 10% of the bearing material was worn away.

Photo 15: Heavy grooving on the PTFE surface. One wear mark removed. Only 0.002 inches of material was worn.

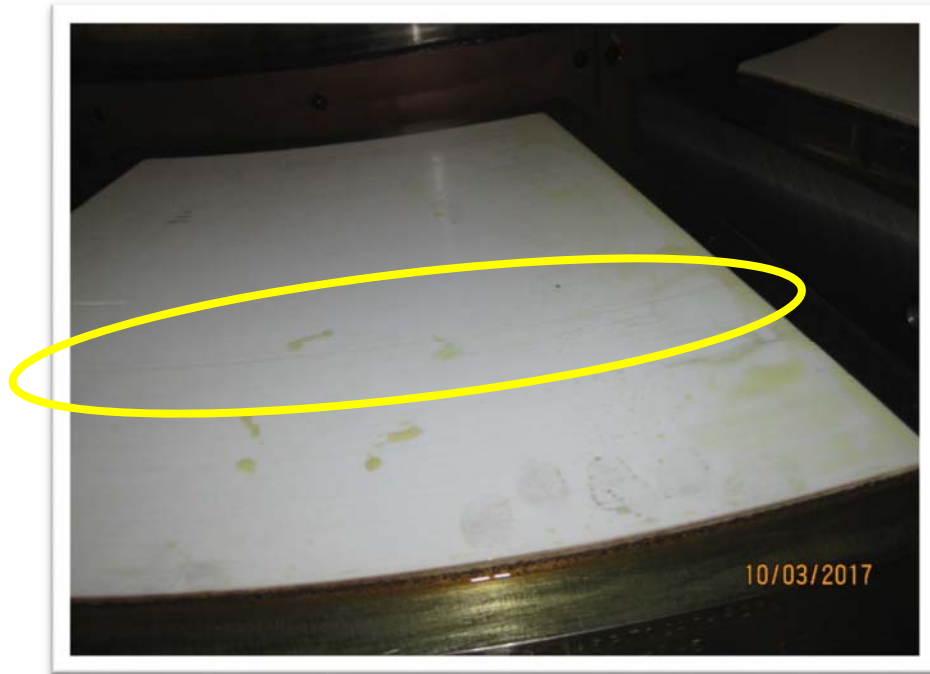
Photo 16: Heavy grooving on PTFE surface
