## **Thrust Bearing Retrofit: A Case Study of the Cataract Generating Station**

By Paul Plante and Eric D. Soule, FPL Energy, Maine Generation, USA and  
Mike Dupuis, Hydro Tech Inc., Canada

*Located on the Maine coast, the Cataract Generating Station, a single unit station owned by FPL Energy-Maine Hydro had experienced recurrent thrust bearing failures. The unit is a 9000 HP, Kaplan-type runner that started commercial operation in 1938. A review of maintenance history at Cataract has indicated the unit experienced eight thrust bearing failures since 1959, with four of them occurring since 2003.*

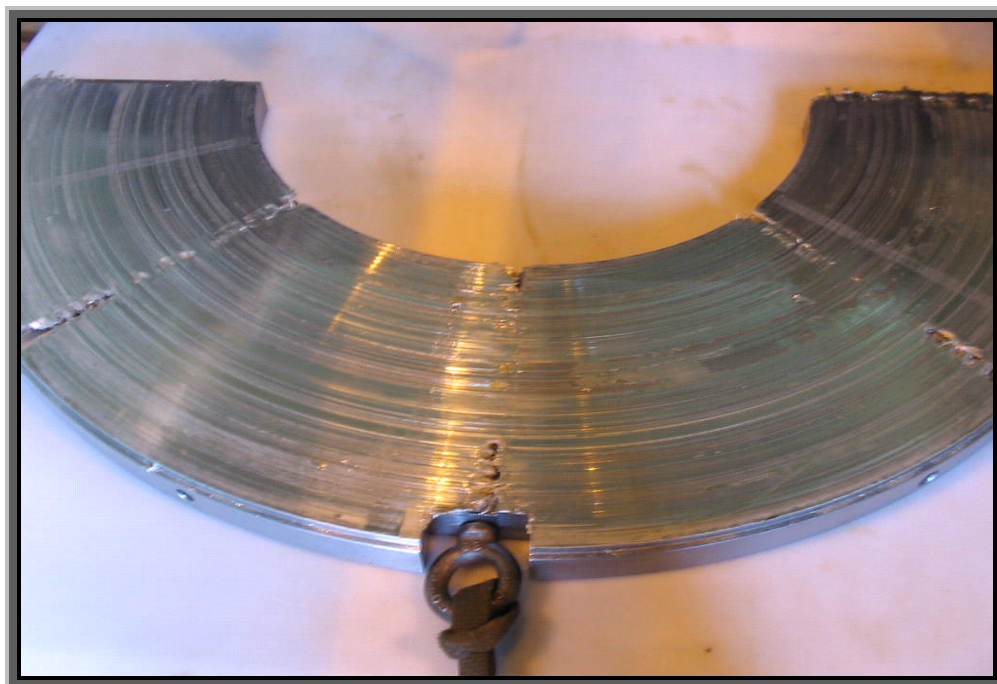
**Figure 1. Photograph of Failed Babbitt Plate from June, 2005**

Initial startup at the station took place in June, 2005 using normal startup procedures. Mechanical runs were conducted without incident. Subsequently, an auto-start sequence was initiated and shortly thereafter, the unit was tripped on high thrust bearing temperature. Subsequent inspection showed a severely wiped bearing with a babbitt-filled oil reservoir as seen in Figure 1.

An investigation was conducted to determine the cause of failure. A conclusive root cause was not determined at this time. One item noted during the disassembly of the failed bearing showed that the round keys that hold the split thrust runner halves in place to each other were distressed. There are two keys held in place by set screws and one key was ejected and in the thrust bearing oil reservoir and one was still in place. Both had sheared set screws. A small amount of displacement was noted between the thrust runner halves.

Recovery from this failure involved a series of steps that included thrust bearing component reengineering. A new, split half thrust runner was built that included a robust key set to address the disrupted runner issue from the June 2005 failure. Additionally, a two piece babbitt plate was provided to replace the existing damaged babbitt plate. This was because there was a concern with warping the original babbitt backing plate during the rebabbitting process. The unit was reassembled and subsequently prepared for restart in September, 2005.

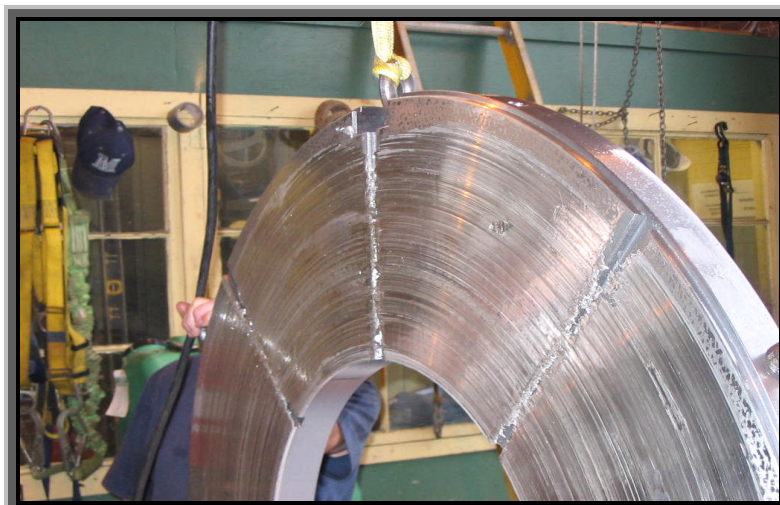
**Figure 2. Photograph of Failed Babbitt Plate from September, 2005**

The second startup progressed normally through a run that included flashing the field. Subsequent to that variable, the unit was auto-started and synchronized. Thrust bearing temperatures started to climb dramatically and the unit was tripped. Upon disassembly, a preferential wipe in the babbitt was discovered that was so severe the unit had to be disassembled and thrust bearing components either had to be repaired or replaced (Figure 2).

Upon disassembly after the second failure, displacement was once again noted between the two halves of the thrust runner, despite the enhancements made to the keys to improve their rigidity and stiffness. At this time, the thrust bearing was completely removed from the unit and a multidisciplinary team was assembled to determine root cause for thrust bearing failures and the appropriate corrective actions to prevent recurrence.

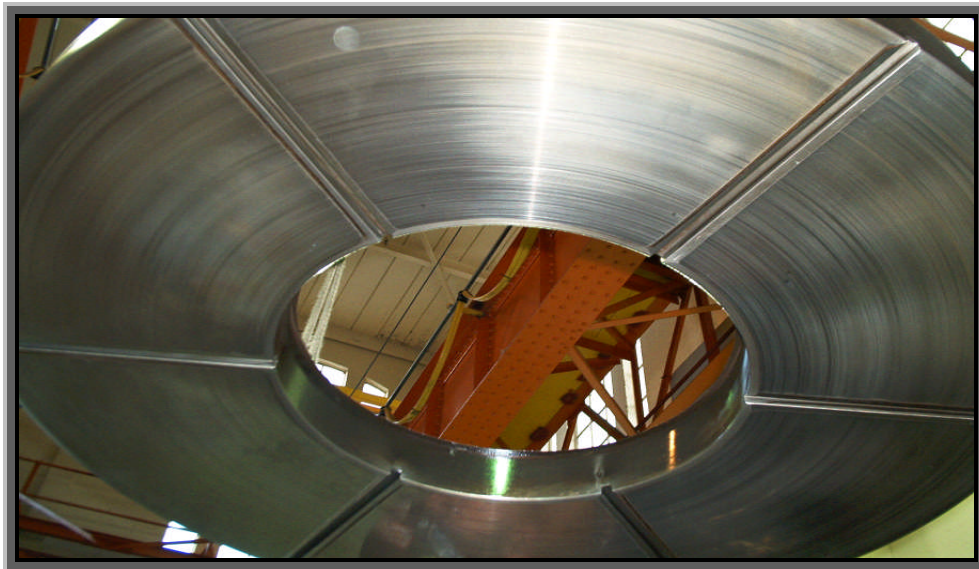
**Figure 7. Grooved Thrust Runner Plate**

The thrust runner plate resembles a runner plate of current design, except for the presence of radial grooves on the face of the running surface as shown in Figure 7. Originally designed to circulate oil in the bearing pot, and to wash cool oil over the face of the babbitt pads, these radial grooves actually contribute to the bearing's downfall. As the grooves pass over stationary pads, the oil wedge is broken, thus allowing pressure developed to support the thrust load, to drain from the radial groove. This results in an unequal distribution of load on the thrust bearing pads by changing pressure across the bearing pads from maximum to zero pressure (six or more times per revolution depending on the number of radial grooves).

Such extreme pressure changes inevitably cause problems. “Oil pressure hammer” may cause fatigue cracking of the babbitted surface. Additional cases have been documented where pressure drop on a babbitt bearing pad has resulted in cavitation. In both cases, the higher the bearing is loaded, the more rapidly its failure will occur. These failures are sometimes difficult to detect due to the very nature of their occurrence. The bearing operates perfectly while slowly deteriorating; then, after several years of operation, the bearing suddenly self-destructs, leaving little evidence as to the root cause.

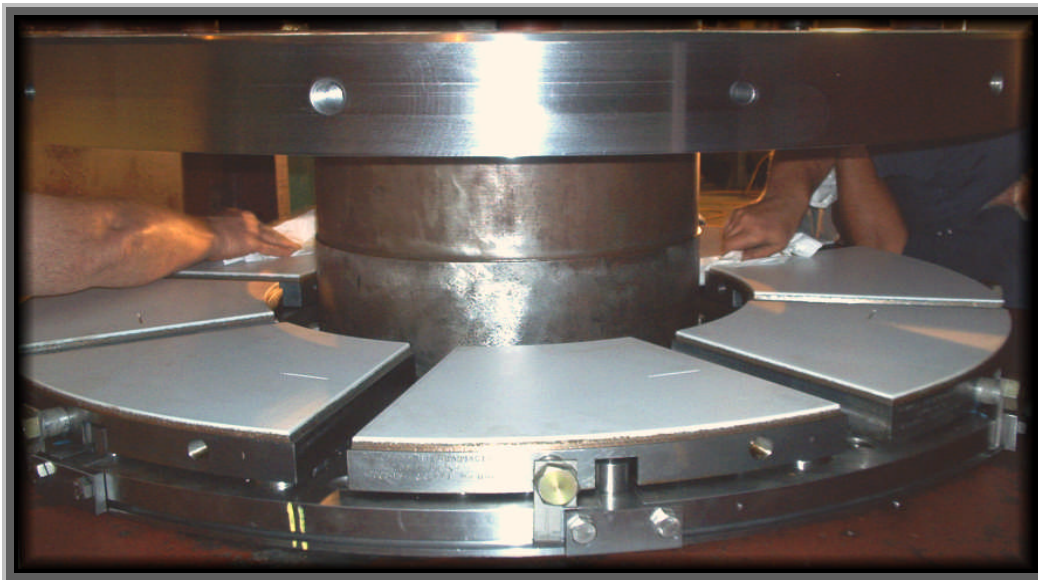
**Figure 8. Converted PTFE Thrust Bearing**

The new Cataract bearing now operates at 50 degrees Celsius (about 30 degrees lower than the previous operating temperature). The oil bath temperature was significantly reduced by 25 degrees Celsius. This is especially important during operation in the summer months where the Unit has a history of running hot due to high ambient temperature and increased river temperatures (cooling water to the thrust bearing oil reservoir).

This obstacle was overcome by designing a new way in which to support the bearing and hold the bearing pads without modifying the bearing pot (Figure 8). Once the four blocks for the old bearing were removed, the new support system was installed, in a single morning, by two tradesmen. The new, rigged, support system supplies a greater thrust load capacity than the previous bearing, and because of the greater efficiency of the PTFE bearing (5 times lower coefficient of friction), results in reduced torque load.
