AKOSOMBO HYDRO-ELECTRIC POWER STATION GENERATOR THRUST BEARING UPGRADE CASE STUDY

Co-Authored by: Ken Arthur, Chief Mechanical Engineer of Akosombo Generating Station of the Volta River Authority and Mike Dupuis, Bearing Specialist & President of Hydro Tech Inc.

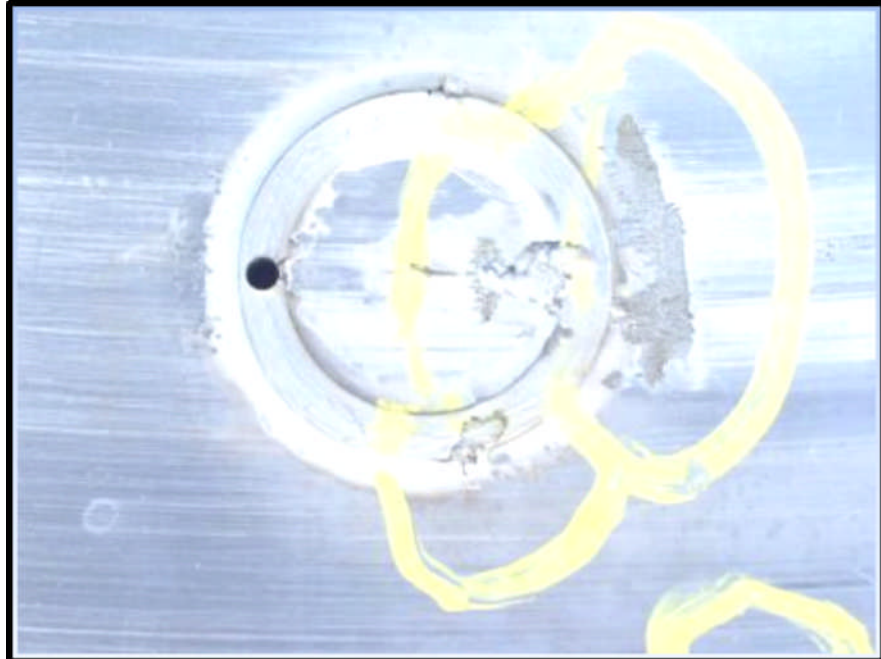
The spring optimization definitely reduced thrust bearing operating temperatures; nonetheless, the emergence of a rather rapidly recurring cavitation damage phenomenon became obvious on the thrust pad surfaces. This pitting effect was normally concentrated within, and around, the High Pressure Oil Injection (HPOI) groove ring, towards the trailing end.

There are few cases of cavitation on thrust bearing pads. A design flaw must exist to allow cavitation to manifest itself when caused by a sudden pressure drop. In this particular case, the highest measured average bearing pressure is approximately 4.07 Mpa; however, this 4.07 Mpa is an average pressure. There also exist higher and lower pressures on the surface of the bearing. Generally, a higher load area is located in the middle of the bearing pad surface toward the trailing edge, close to where the High Pressure Oil Lift (HPOL) ports are. The HPOL port is where the most significant pressure drop occurs due to the change in oil film thickness and/or pressure (step in the babbitted surface and gap between the thrust bearing runner plate segments). With the increased thrust, the oil film between the Babbitt thrust bearing pads and thrust bearing runner plate has decreased, while the average pressure has augmented. This increased the pressure drop at the thrust bearing runner plate split, as well as increasing its subsequent effect on the Babbitt due to close proximity, resulting in the thrust bearing pads showing signs of cavitation pitting (Photo 1).

Photo 1
Old Babbitt Bearing Pads With Cavitation

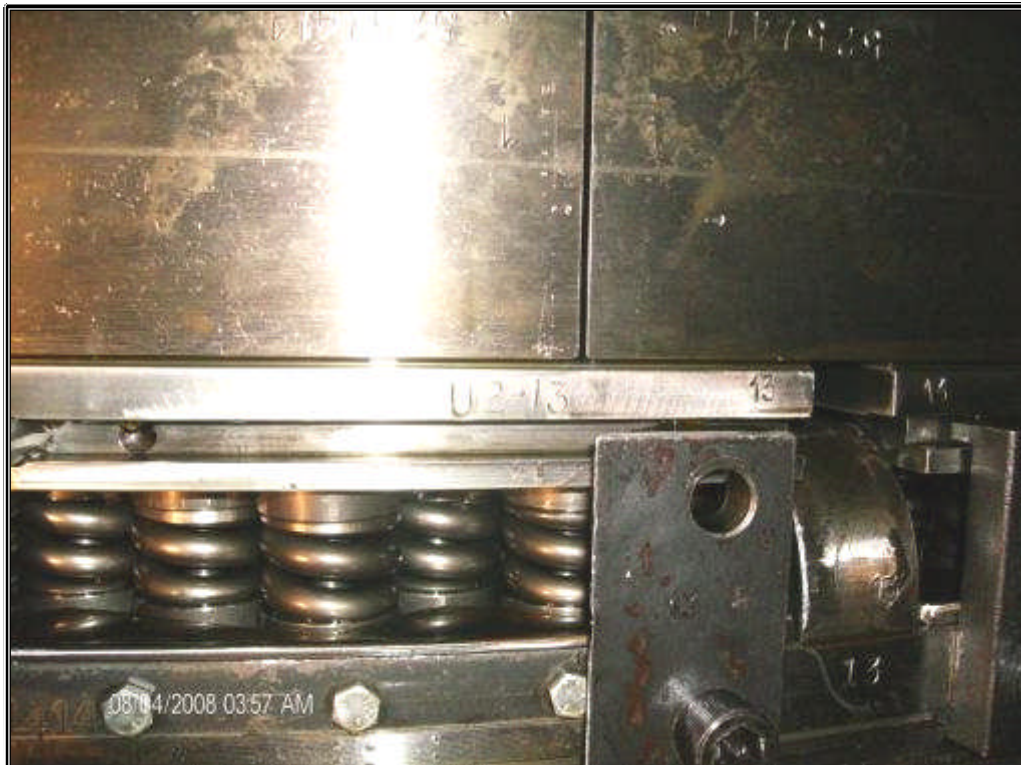
Photo 2
Old Runner Plate With Gap Between Segments

These problems were fundamentally attributed to the increased hydraulic thrust load of the new replacement turbine runner; however the original bearing was already susceptible to cavitation due to gaps in the runner plate quadrants. Prior to the turbine upgrade, there was at least one incident where cavitation was discovered on a bearing pad. At the time of discovery, the cavitation was considered to be porosity in the Babbitt. No further investigation was conducted at this time due to the area being small (approximately .75 inches in diameter).

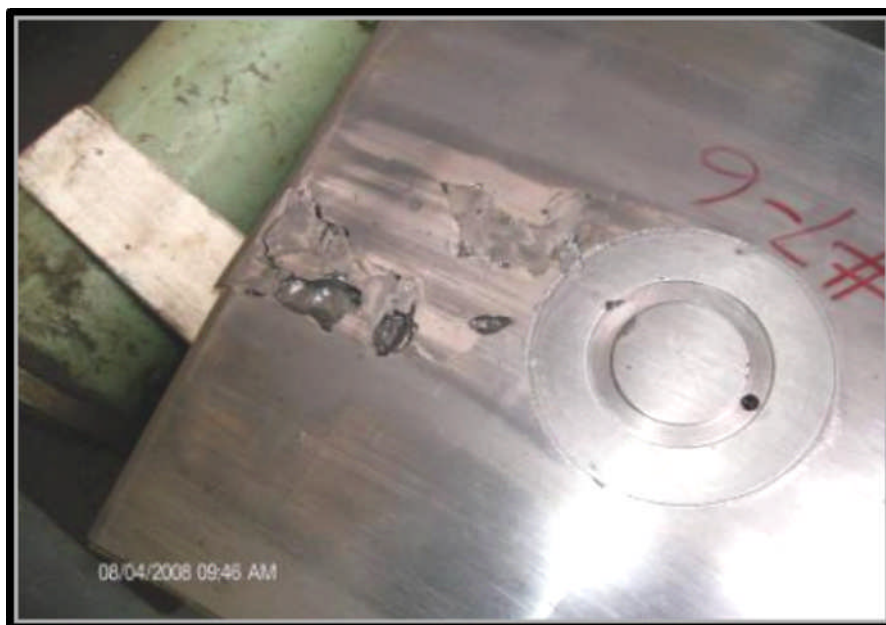
There was also evidence of fatigue failure of the Babbitt surfaces, likely due to thermal effects, a condition known as “thermal ratcheting”. Thermal ratchet is caused by temperature changes on the bearing surface causing the Babbitt bearing pad to act as a bi-metal strip slightly bending the bearing pad causing a crowning. This is caused by the Babbitt expanding and contracting at a different coefficient of expansion to steel, and the surface of the bearing pad being hotter than the steel backing plate to which the Babbitt is bonded (the thicker the Babbitt, the stronger the thermal ratcheting effect that occurs) (Photo 3).

Photo 3
Cracked Babbitt

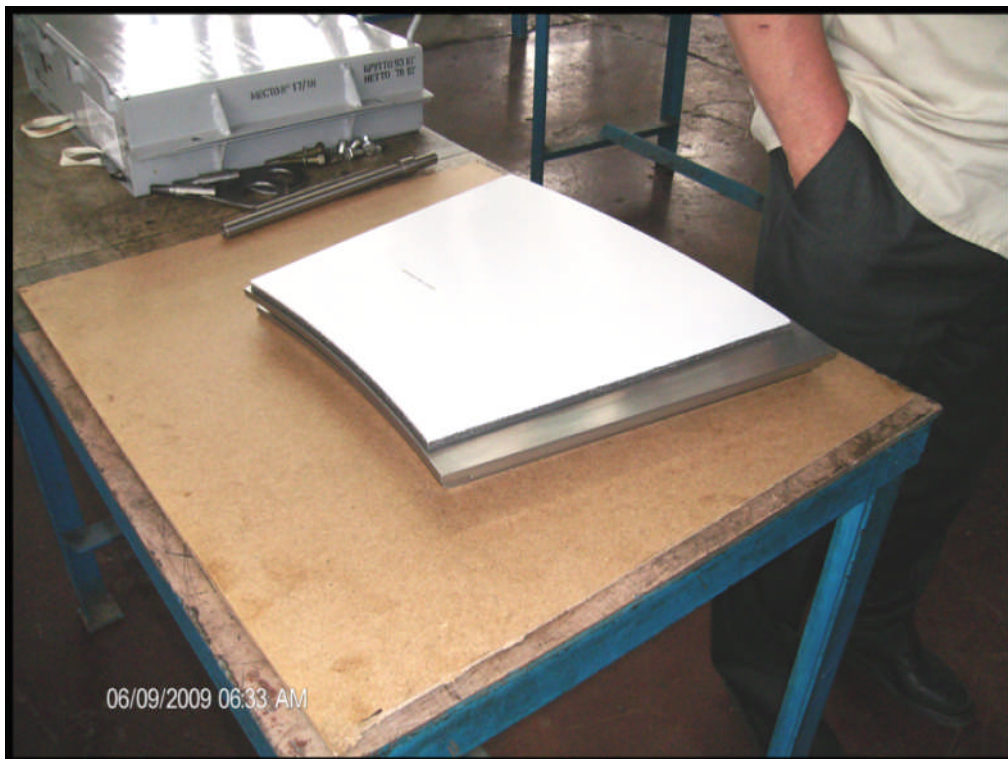
Photo 4

New PTFE Bearing Pads

Superior PTFE bearing pads with higher load capacity were installed to replace the traditional Babbitt bearings, which could not adequately match the increased thrust load of the new turbine runners. The new PTFE thrust pads for Akosombo feature compound tapers at the leading edge to facilitate oil flow and wedge formation, as well as pad eccentricity to permit higher specific load capacity. Using the PTFE bearing pads also allowed elimination of the HPOL system removing another potential source for cavitation.

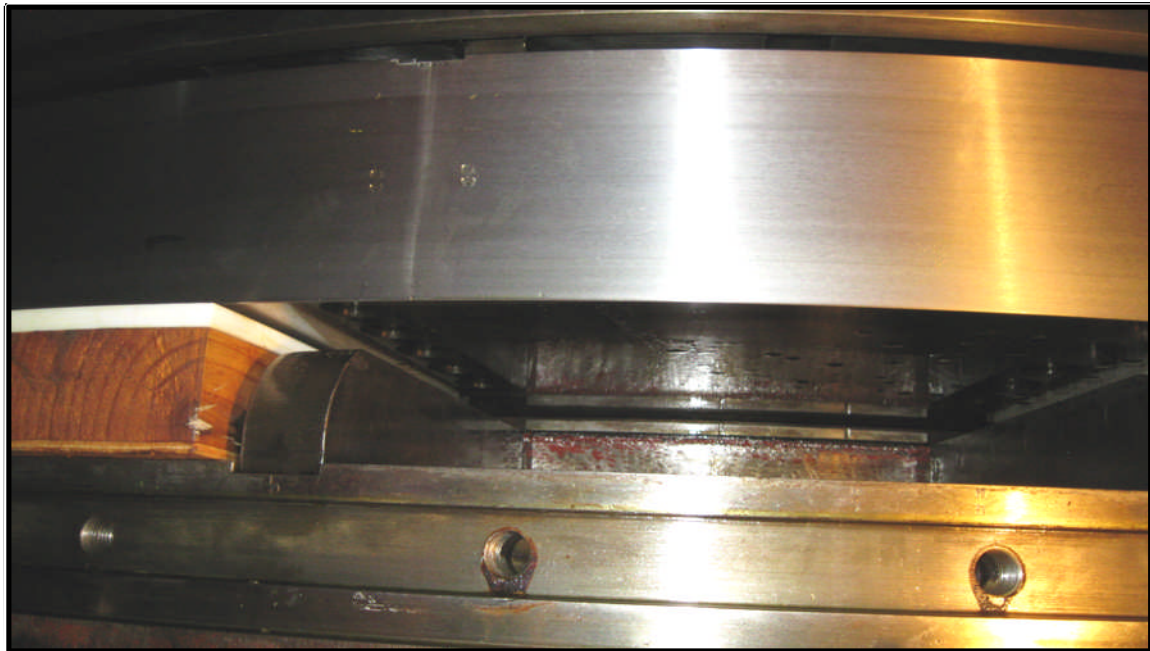
Photo 5
New Runner Plate Tightly Bolted Together

rotating rings was a modified design of highly-toleranced segmented rotating rings, which are keyed and bolted together to ensure zero gaps at the splits. This new design would eliminate sudden pressure fluctuations caused by the splits. This type of joining was achieved during installation. The splits were lapped (stoned) to completely eliminate any sharp ends, eventually forming a one-piece thrust bearing rotating ring which was bolted to the thrust block.

The new thrust bearing runner plate acts as a solid one-piece ring providing constant pressure on the bearing pads over its entire surface. The bearing pad no longer experiences pressure fluctuations from the four quadrant slits that originally relieved pressure from maximum PSI to 0 four times per revolution.
