Thrust Bearing PTFE Re-Design for Pump Storage Generator Case Study

Paper by: Mike Dupuis, President of Hydro Tech Inc., Canada
Tim Maricic, Senior Engineer Specialist of Ontario Power Generation, Canada

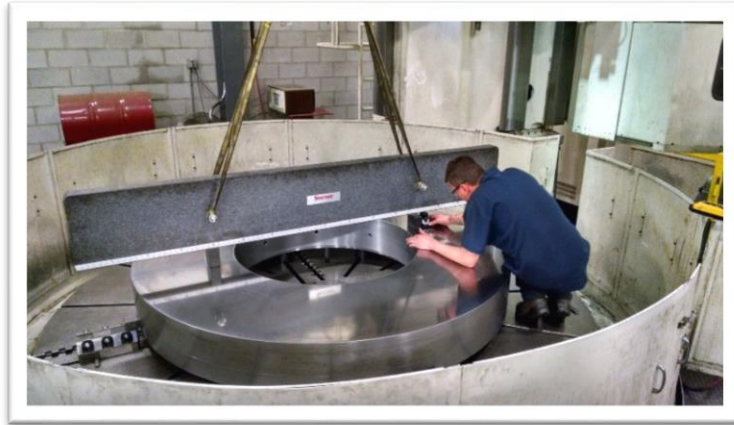
Photo 1 - Measuring the Runner Plate Flatness

With a tightly fitted key, drawing together the runner plate halves is only part of the problem. On disassembly, one must also be able to separate the plate halves. Ease of disassembly must be designed into the runner plate to prevent site personnel from having to damage the mounting or running surface finishes or split faces. For the new PGS runner plate, 20 to 30 tons of force is required to separate the two halves.

Improvements of the bearing now have the runner plate with a clamping value at the split faces being 100 tons total, with a step of less than 0.0001 inches on assembly at both the vertical and horizontal split joints.

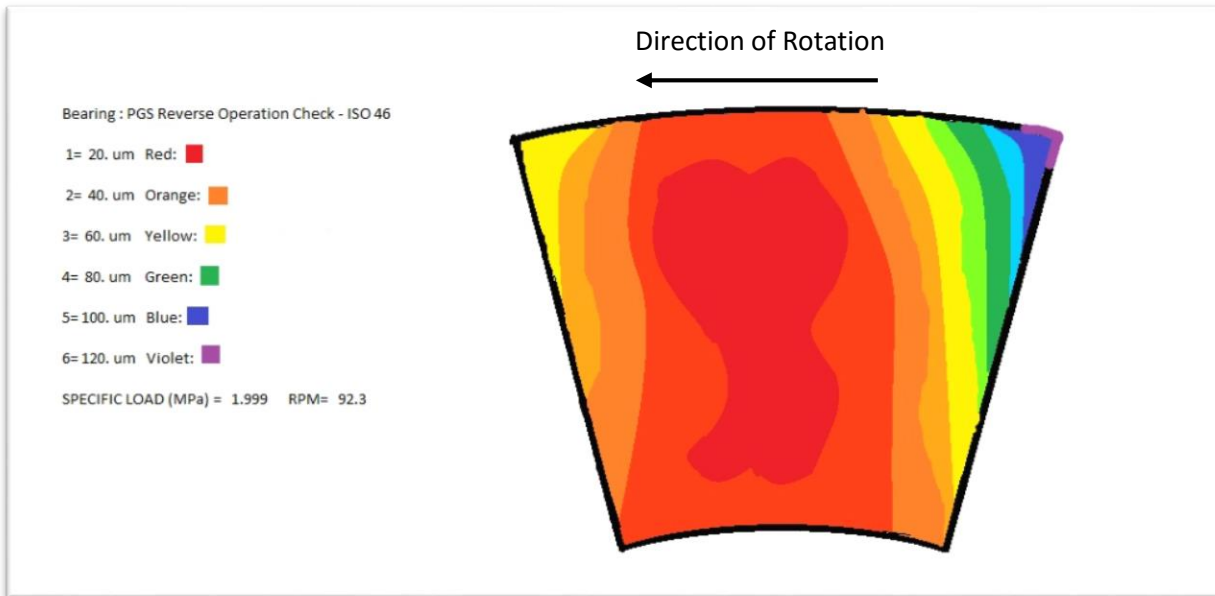
Figure 1 - ISO 46 Oil with Minimal Film Thickness

Temperature was not an issue for the PGS bearing; during normal operation the bearing temperatures were not excessive, therefore the oil viscosity was not thinning due to heat. However, the oil film needed to be thicker to allow the bearing to operate at a reliable safety factor. For the PGS bearing, calculations indicated that the new ISO 68 oil would improve the oil film thickness for this slow rotating generator.

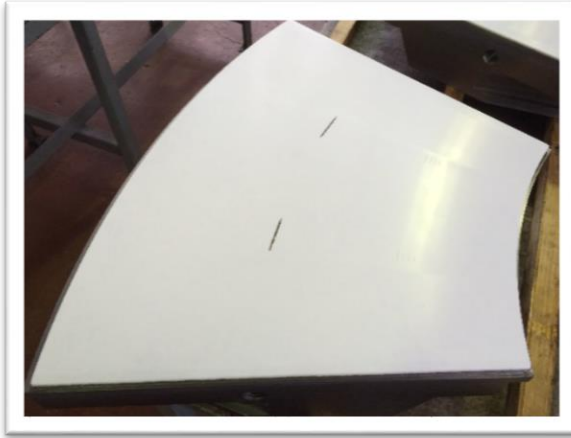
Photo 2 - PTFE Bearing Pad

The new PGS thrust bearing pads have PTFE lining of the frictional surface instead of Babbitt lining. To overcome PTFE's low strength against deformation, the PTFE is reinforced with bronze wire mesh embedded into the PTFE below the running surface. The wire mesh is reliably soldered to the pad steel base. The PTFE operating surface has unique design tapers to provide optimal oil film for the speeds and loads of the PGS bearing. Also, consideration is given for elastic deformation of the PTFE. PTFE lining features excellent antifriction and anti-scratch properties as well as high electric insulation. The dry friction coefficient between Teflon lining and the steel runner plate friction surface is from 0.05 to 0.08, about 20% to 30% compared with the coefficient of Babbitt. Heat-conductivity coefficient for PTFE lining is only 0.05% from heat-conductivity coefficient for steel-Babbitt, which dramatically reduces crowning.

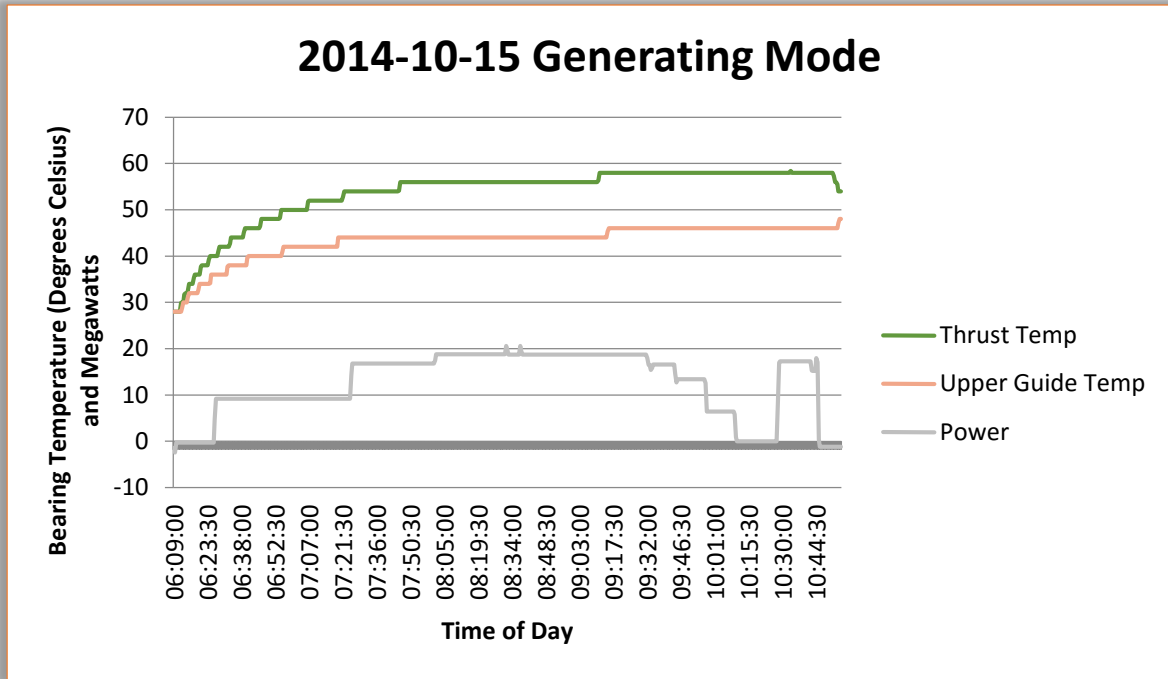
Figure 3 - Bearing Temperature in Generating Mode

The bearing temperature leveled out at 58 degrees Celsius with the RTD placed in the bearing pad's trailing edge, the hottest part of the bearing pad. Starting and stopping was smooth.

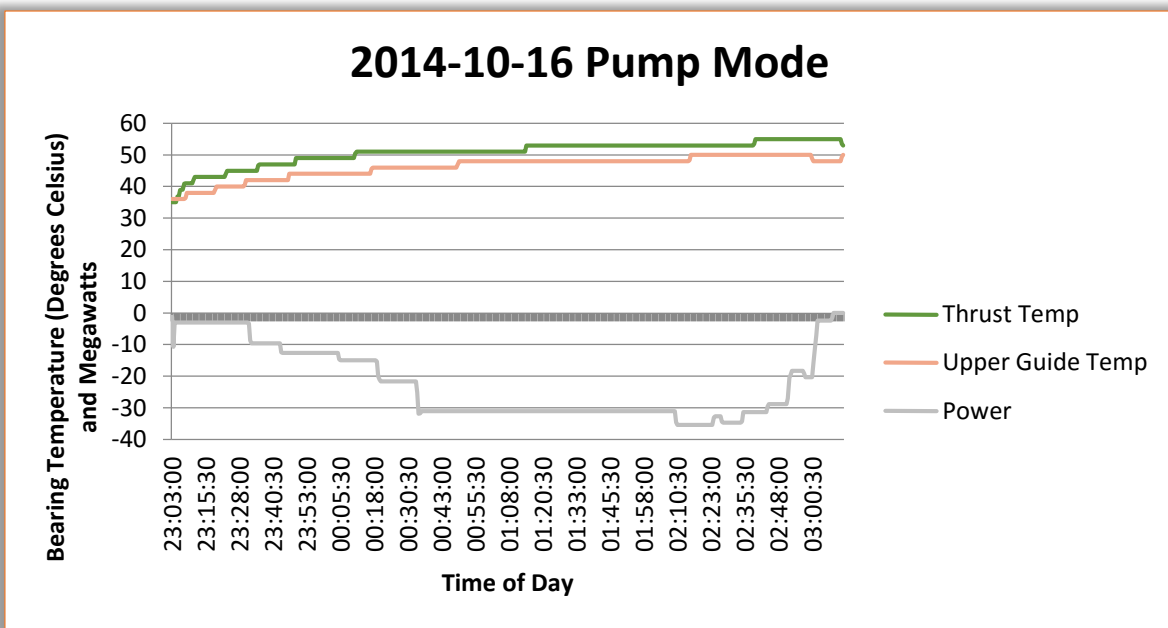
Figure 4 - Bearing Temperature in Pump Mode

The bearing temperature leveled out at 55 degrees Celsius with the RTD placed in the bearing pad's leading edge, not in the hottest part of the bearing pad. However, calculations indicate that the temperature range between RTD placement and the actual hottest part of the bearing pad, is within 5 degrees. Starting and stopping was smooth.
