Site Unit #1

PTFE Thrust Bearing Inspection

after 15 years of service

Heavily Loaded PTFE Thrust Bearing Shows Little Wear After 15 Years

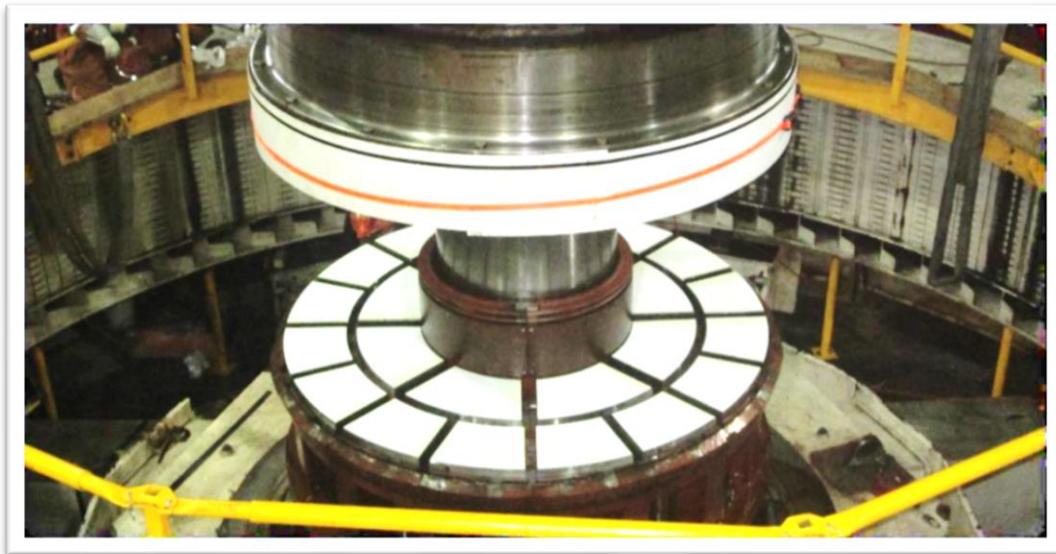
In May 2018, Hydro Tech inspected a set of PTFE (PolyTetraFluoroEthylene) thrust bearing pads after the first fifteen years of service. These bearing pads were supplied in 2003, as an upgrade to the Babbitt bearing pads originally used in the 1400 tonne [1500 ton] thrust bearing which had experienced repeated failures every 2 – 5 years. While most thrust bearings see between 2 – 3 MPa [290 – 435 psi] of average pressure acting on the bearing surface, the pressure acting on this bearing is more significant at 4.4 MPa [640 psi]. Thus, the bearing is more susceptible to damage due to irregularities during operation, such as oil contamination or over-speed events. Whereas Babbitt bearing liners tend to fail outright during harsh operating conditions, PTFE bearing liners are designed to wear over time, and so are machined with wear indicators to estimate the remaining service life of the PTFE. In this case, despite some instances of heavy scoring which may have caused a failure in conventional Babbitt bearing pad, very little loss of the indicators was observed.

In this particular thrust bearing, there are two rows of pads: sixteen on the outer diameter and eight on the inner diameter. Four of the outer bearing pads and two of the inner bearing pads are machined with two indicators each: one near the outer diameter and one near the inner diameter, both towards the trailing edge of the pads. The indicators consist of four concentric circular grooves, with depths starting at 0.05 mm [0.002"] on the outside and incrementing in 0.05 mm [0.002"] steps to 0.20 mm [0.008"] for the innermost groove. Once the 0.20 mm groove can no longer be observed, the pads must be replaced or resurfaced to restore their leading and trailing edges.

The inspection revealed three key points:

- Measurements indicated that the current wear was 0.035 mm [0.0015"] after 15 years of service. At this wear rate, the bearing pads had approximately 70 years of service life remaining before replacement / resurfacing would be required.
- Dimensional inspections indicated that the pad parallelism and overall thicknesses were still within the original manufacturing specification.
- The visual inspections did not reveal any serious defects, such as crack indications on the PTFE surfaces or at the liner-shoe interface. As noted above, heavy grooves were observed on some of the pads, likely caused by contamination of the bearing oil. This localized damage did not affect the condition of the rest of the pad, and no remedial action was required.

Thus, the inspection was able to conclude that the PTFE bearing pads had performed very well in their first fifteen years of service, under conditions that had caused the original Babbitt bearing pads to repeatably fail. They were returned to the client, ready for re-installation and another 70 years of use.
