## A Case Study of an S-Turbine Seal Failure

By: Michael Detenbeck, P. Eng., Hydro Tech Inc.

Site: Energy Ottawa New York, Dolgeville Generating Station

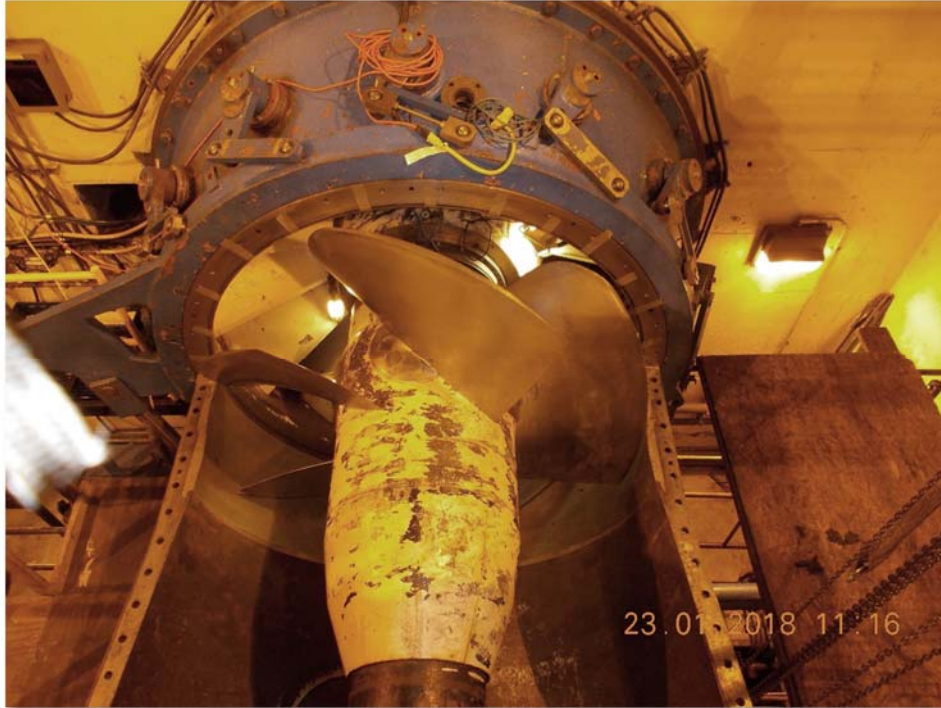
**Photo 1: Turbine with discharge ring removed for access to seal area**

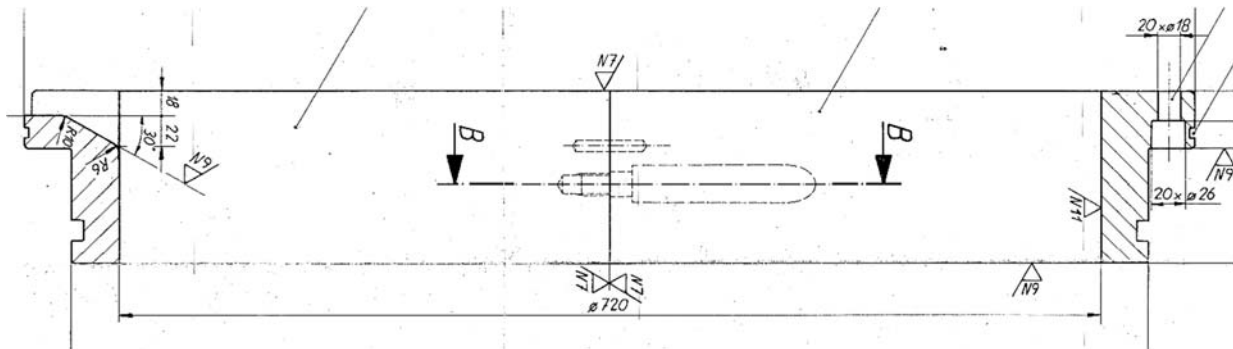
Figure 3 – Inner Seal Ring

The inner seal ring was made from cast G25 carbon steel and painted on the exposed surfaces but not in the piston chamber area and O-ring seats. One pair of bolts and one pair of locating pins keeps this part in alignment. Note the position of the O-ring groove.

Imagine this part having water sit stagnant in the O-ring groove and on the outer surfaces where the piston slides. Corrosion will always be the enemy here, eating away at the O-ring lands and binding up the movement of the piston.

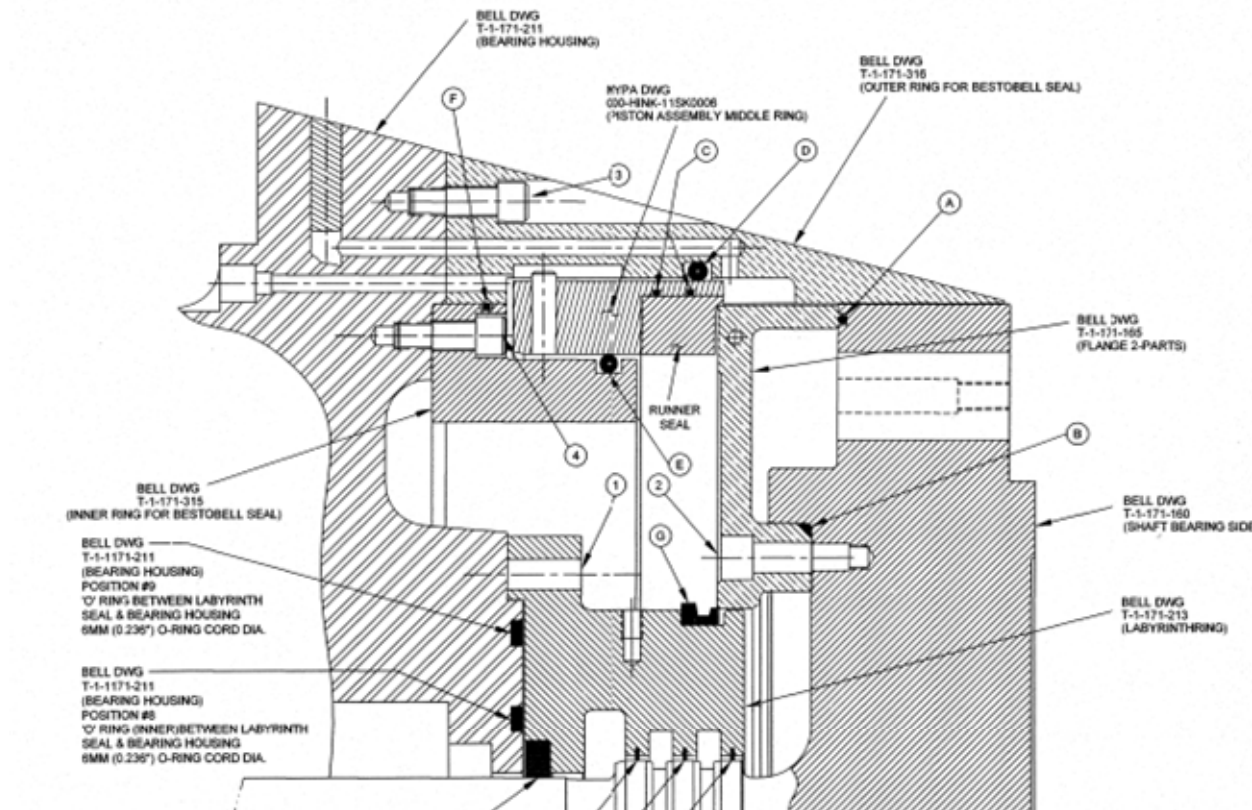
Figure 4: Section View of Bestobell Seal

Seal replacements based on the purchase records from the OEM were ten (10) seal elements over a (31) thirty-one year period. The operating time on these seal elements was less than 25 years. The average operating life was approximately 2.5 years to failure, and in the last three years the life was down to days:

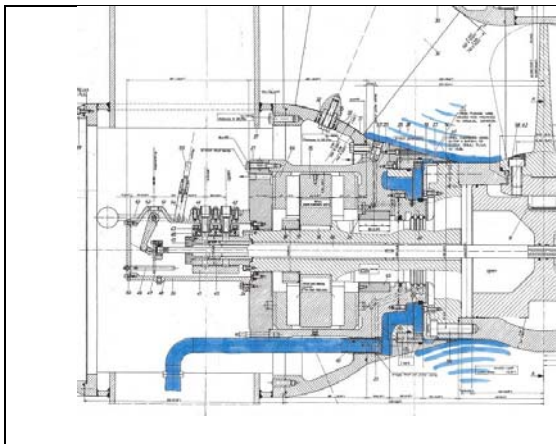
**Fig 5: Drain path**

Records of commissioning commencing from 20 June 2017 were available. A turbine specialist company was hired to do the work and provided an aftermarket seal element. This seal element was installed and immediately began to overheat and smoke. The unit was shut down on 21 June 2017 without going on-line. The unit was re-started at a restricted speed of 50% during no-load conditions and put on-line. On June 25 a leak arose in the lower stay vane area (*Figure 5*). It turned out that the seal had fragmented and was clogging the water drain (*Photo 7*).

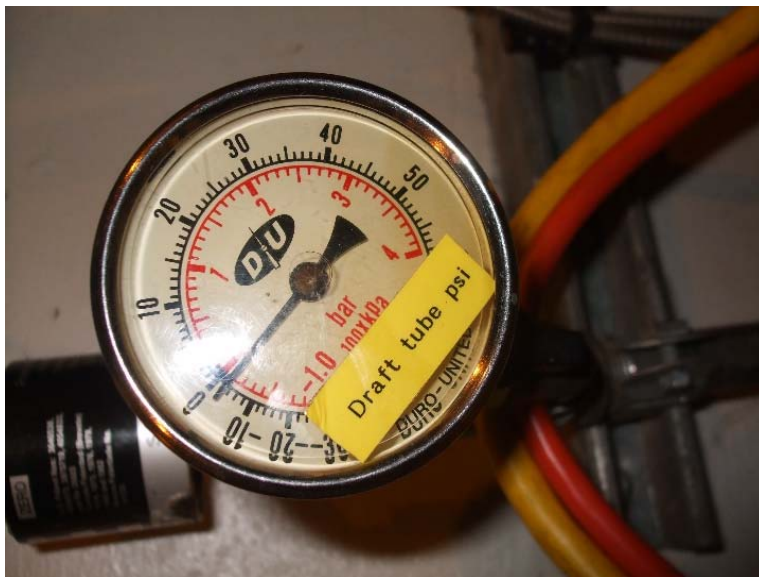
Photo 11: Draft Tube PSI

Several claims during the overhaul in 2017 were made that the seal failures were caused by a perceived vacuum condition occurring during start-up. The evidence to support this was a pressure gauge that the needle was pegged past zero psi. This condition was thought to diminish the water flow across the seal face.

It was noted that when the seal wears and the piston is extended, it closes off the opening to the old pressure port. As we were using this port to provide water, we modified the outer seal ring by cutting in a slot and closing the clearances by adding a bronze band. In hindsight, it turns out that when the piston closed over this port, when in original factory condition, a vacuum was occurring that was being read as negative penstock pressure.

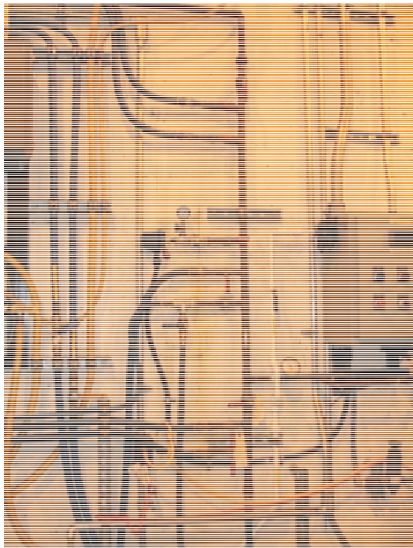
**Photo 15: Seal control panel**

A thorough study of the startup procedure was carried out. During the life of this unit some design changes to seal controls were made. This complex control system provided a method to maintain water pressure to the back face of the seal piston and a rudimentary float switch system used to monitor water discharge from the drain of the casing. Both components had feedback to the turbine control system and alarms to indicate functionality.

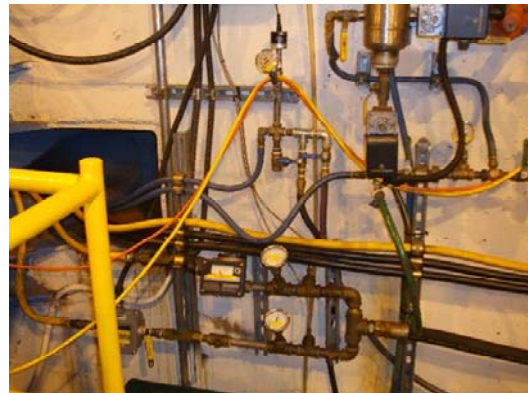
**Photo 16: Air/water distribution headers**

To remove the potential that silted river water was a factor, this additional supply was necessary. Because city water supply volume was limited and was also used to cool the bearing oil through a heat exchanger system, a secondary source of water was established. This secondary supply came off the penstock and was filtered through a strainer. This filtration system was reconditioned.

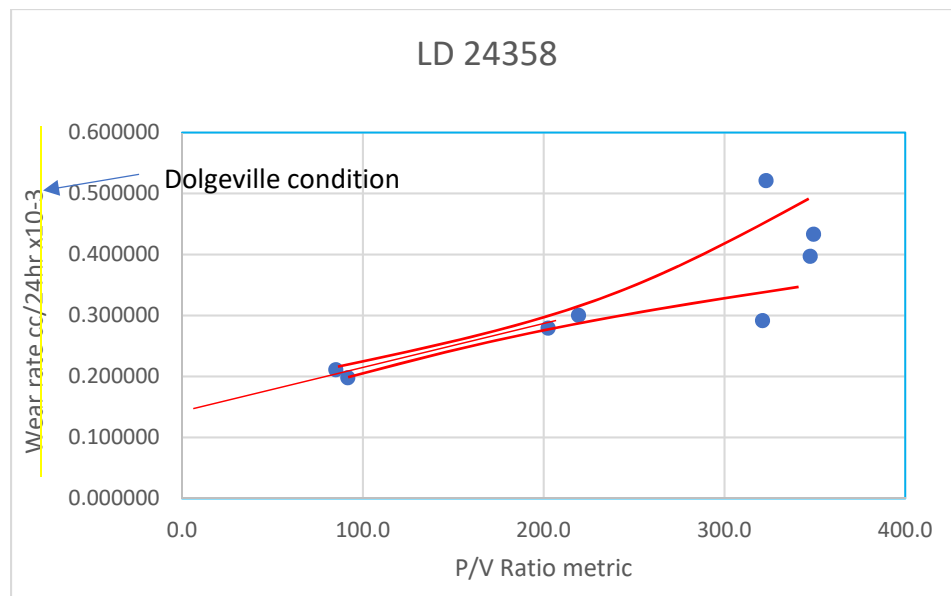
**Figure 7: Test Condition - Flooded**

The results indicate that as the P/V value goes up, the LV seal outperforms the L/D material. In flooded conditions, under the P/V value the seal element is set up to run at Dolgeville, the wear characteristics favour the LV material only marginally.

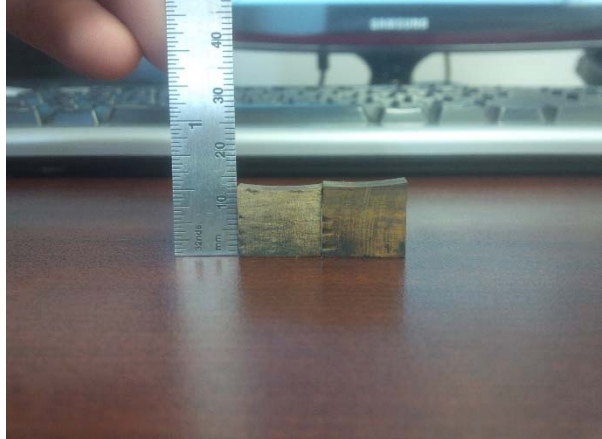
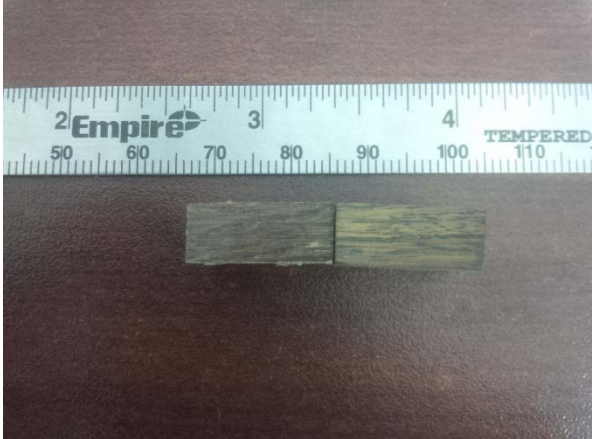
L/D Sample (Ring #3)	LV Sample (Ring #2)	L/D Sample (Ring #3)	LV Sample (Ring #2)

Note: the wear ring #3 surface finish was dressed before profilometer readings could be taken, but it exhibited the same deep circumferential grooves that were observed on ring #4.

<p>Axial Surface Finish R<sub>z</sub>: (Na)</p>	<p>Axial Surface Finish R<sub>z</sub>: 0.29 μm – 0.37 μm</p>

<p>L/D Sample Total Wear: 3.19 mm</p>	<p>LV Sample Total Wear: 2.27mm</p>

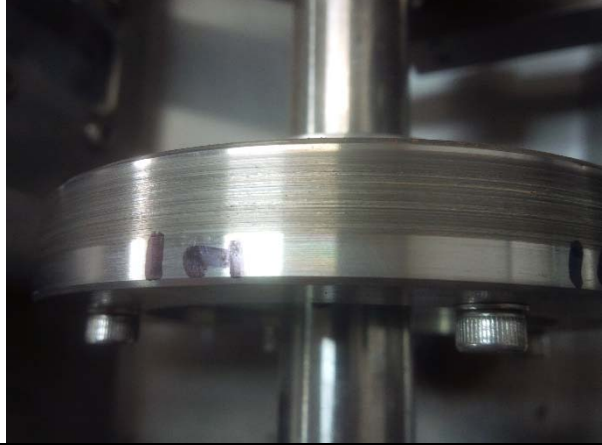
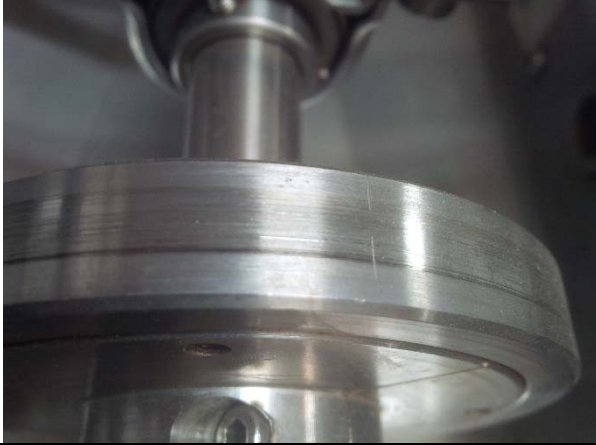
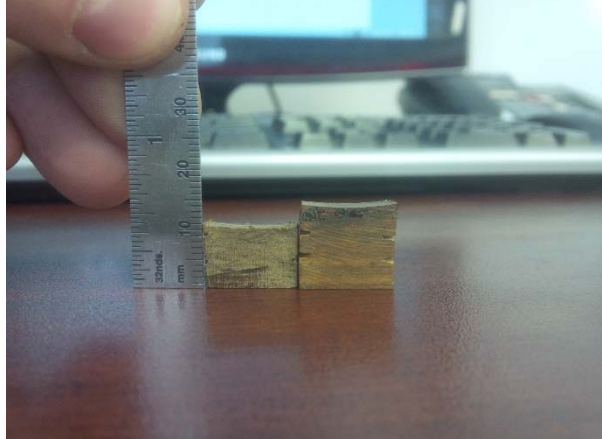
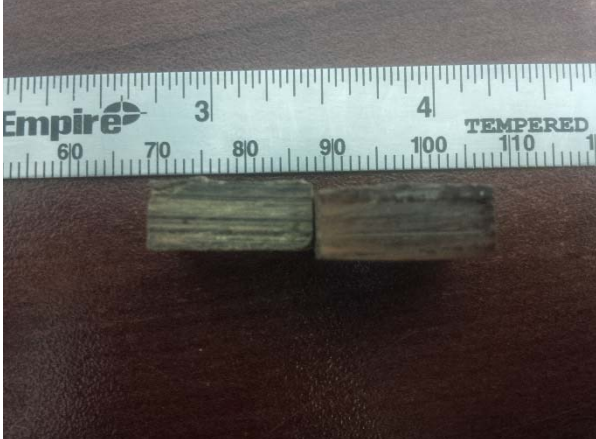
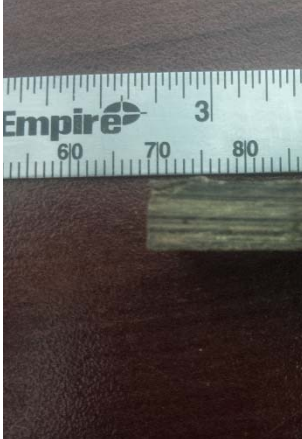
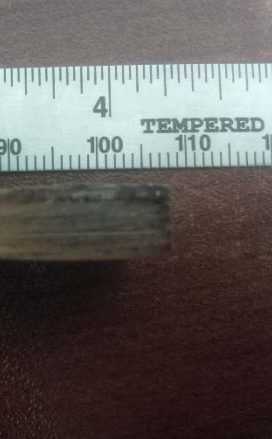
L/D Sample (Ring #4)	LV Sample (Ring #1)	L/D Sample (Ring #4)	LV Sample (Ring #1)

<p>Axial Surface Finish <math>R_z</math>: 2.68 <math>\mu\text{m}</math> – 2.90 <math>\mu\text{m}</math></p>	<p>Axial Surface Finish <math>R_z</math>: 0.33 <math>\mu\text{m}</math> – 0.39 <math>\mu\text{m}</math></p>

<p>L/D Sample Total Wear: 5.75 mm</p>	<p>LV Sample Total Wear: 2.11 mm</p>	<p>L/D Sample Total Wear: 5.75 mm</p>	<p>LV Sample Total Wear: 2.11 mm</p>

These limited tests indicate that Lignum Vitae is much less abrasive to shaft journals than an equivalent material under dry conditions. One possible explanation might be that the L/D samples have been observed to produce large quantities of fine particulate, which may result in increased abrasive wear on the collars. Another explanation is the natural lubricating properties of Lignum Vitae.
