## **Thrust Bearing Retrofit: A Case Study of the Cataract Generating Station**

By Paul Plante and Eric D. Soule, FPL Energy, Maine Generation, USA and  
Mike Dupuis, Hydro Tech Inc., Canada

*Located on the Maine coast, the Cataract Generating Station, a single unit station owned by FPL Energy-Maine Hydro had experienced recurrent thrust bearing failures. The unit is a 9000 HP, Kaplan-type runner that started commercial operation in 1938. A review of maintenance history at Cataract has indicated the unit experienced eight thrust bearing failures since 1959, with four of them occurring since 2003.*

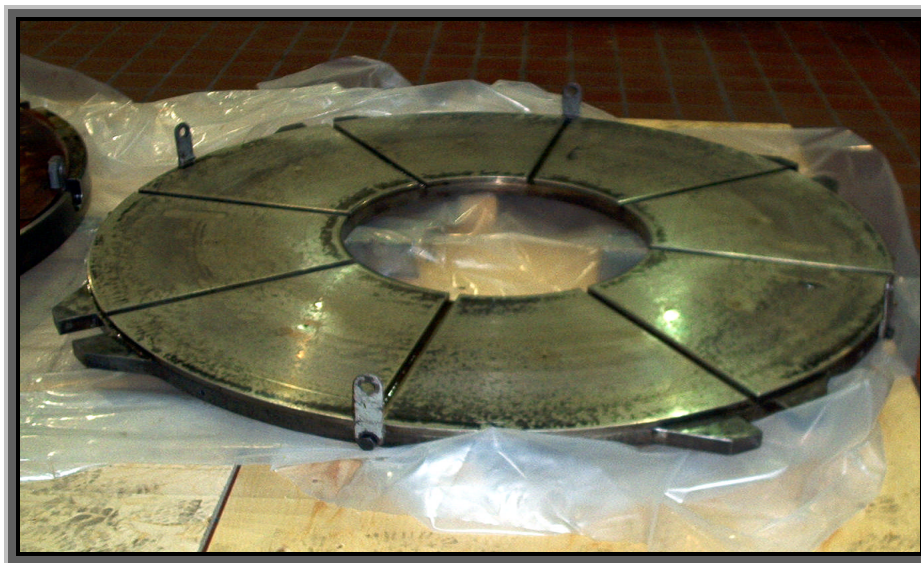
**Figure 4. Babbitted Bearing Plate - Flat, Spring Supported Style**

The thrust bearing assembly consists of two flat annular rings, one fixed to the shaft, one to the housing. These rings turn against each other in a flat-bottomed “pot” which holds a bath of non-compressive hydraulic oil. The bottom ring (the “bearing plate”) is fixed to the pot bottom, and usually has six or eight radial grooves to promote continuous feed of oil between the surfaces of the two plates; the stationary bearing plate has a babbitted bearing surface (Figure 4). The top rotating ring (the “runner” plate) turns with the shaft. As is typical with this style of bearing, the runner plates also have radial grooves.

The typical flat plate thrust bearing was a marine design used for many years on ships. The original design of the flat plate thrust bearing came as either one complete base ring, or in two base ring halves. Both arrangements had babbitted bearing pad sections bonded to the base plate. This arrangement was frequently held by blocks in four places on the outside diameter of the bearing base plate(s). The thrust runner plate for this bearing was a micro finish plate with radial grooves on the running surface. These grooves acted as a centrifugal oil circulating pump for the bearing pot. This design was largely used in many generators as late as the mid 1940's.

After this time, it was common knowledge among bearing designers that a tilting pad plain bearing had a 2 to 4 times greater load carrying capacity than the flat plate design. A flat plate babbitt bearing design can safely operate at approximately 150 psi compared with the 400 to 450 psi of a babbitt tilting pad design. The PTFE tilting pad bearing has a design load of 6.5 MPa (943 psi), which is more than twice that of babbitt. All three styles of bearings have operated successfully at greater than the design loads, however, the design safety factor is reduced.

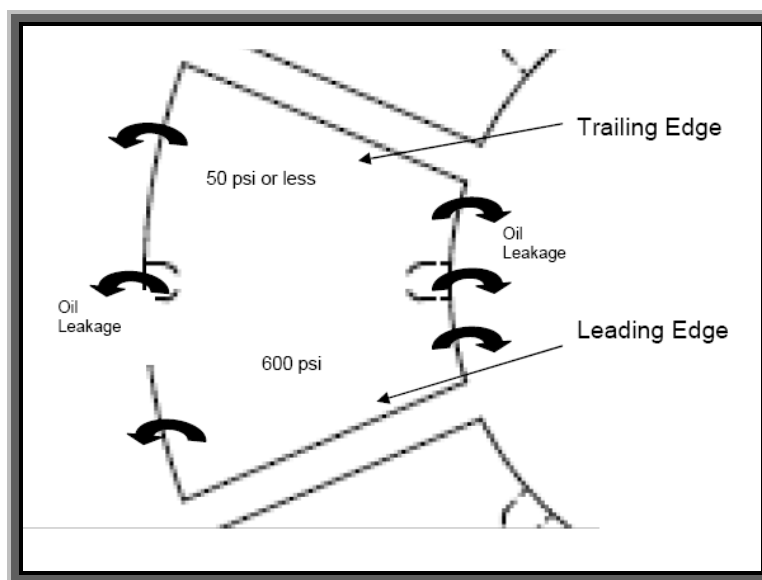
**Figure 5. Flat Plate Design for Oil Wedge**

Flat plate babbitt pads are bonded to a single base plate, keeping them parallel to the runner (rotating) plate. Lubrication is drawn onto a bearing pad's surface by oil sticking to the runner plate as it rotates; this creates an "oil wedge" at the leading edge of the bearing pad. As oil travels along a pad, some oil leaks from the inner and outer pad edges, thereby, leaving less oil pressure at the trailing edge of the bearing segment (Figure 5). This is an effect of the bearing pad's parallel position to the running surface, resulting in reduced oil pressure at the back of the pad due to oil leakage. This leaves only the leading edge of the pad to support the majority of the thrust load. The effective working area of the flat plate bearing pad is only about 1/3 its surface area.

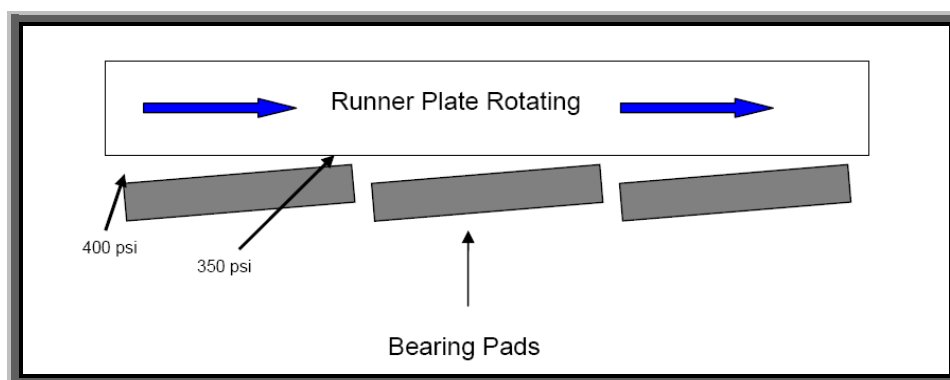
**Figure 6. Tilting Pad Design Oil Wedge**

By contrast, a modern bearing design uses a forward-tilting pad to create a smaller gap between the runner plate and back of the bearing pad. This allows the trailing edge of the bearing pad to maintain pressure despite reduced oil (Figure 6). Thus, a more even distribution of load is created along the entire bearing surface, and the thrust carrying capacity is increased.
